Residential Property Inspection Services

Inspection Report

Property Address:
1000 Rock River Rd
Denver CO 80000

Cozy Home Inspection Services LLC

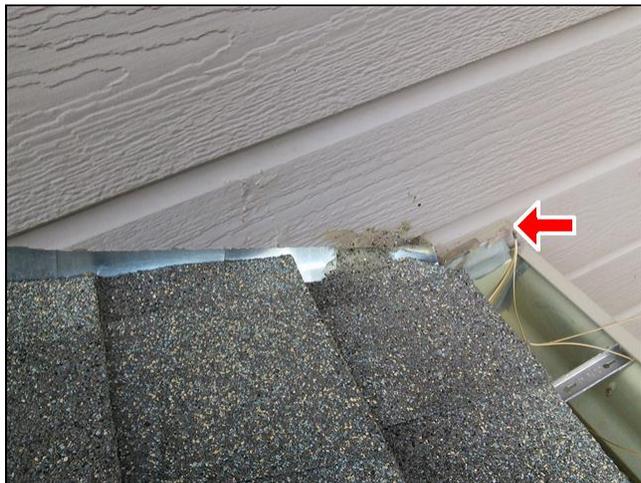
1.1 Item 5(Picture)

🏠 (2) There are areas that would benefit from kickout flashing installation. (see the image titled "Example of kickout flashing" below) Kickout flashings are recommended where a roof and exterior wall intersect so as to divert water away from the wall cladding and into a gutter. When properly installed they can provide excellent protection against the penetration of water into the building envelope. It is recommended to consult with a roofing specialist with regard to evaluation and installation of this flashing material.

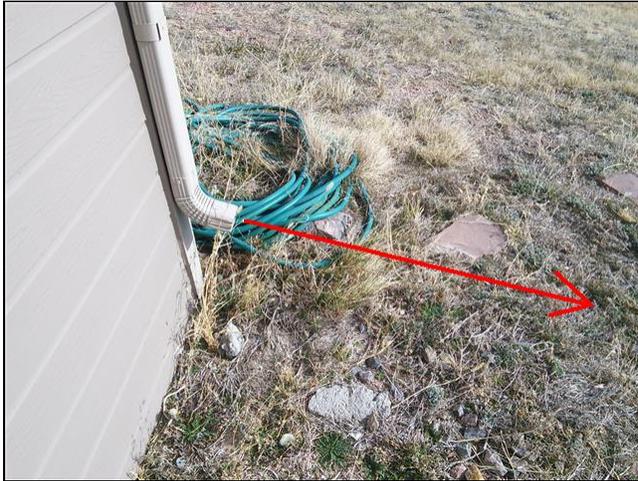
1.3 Item 4(Picture)

🏠 (2) At least one downspout extension is disconnected and should be serviced. All downspouts should be extended well away from the foundation. Recommend a qualified person install missing downspout extensions.

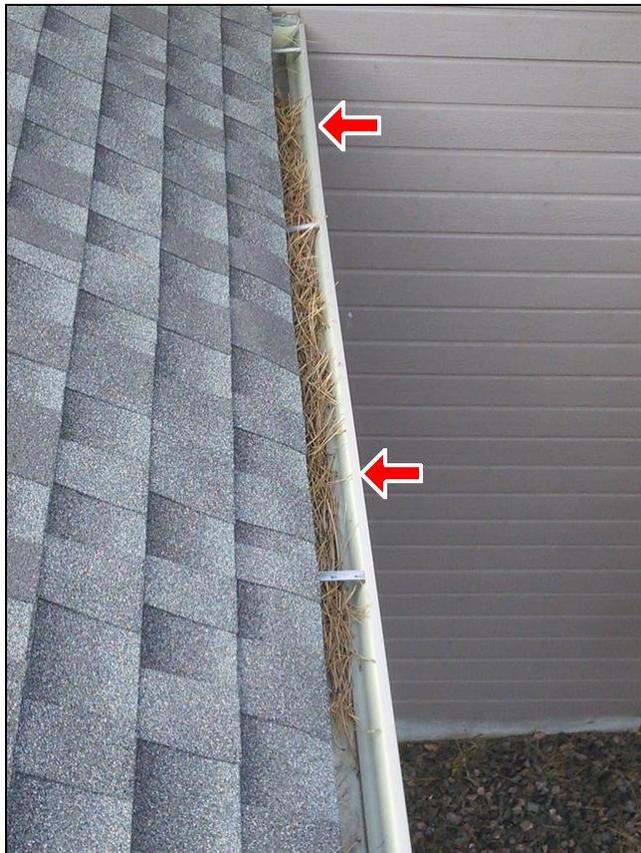
1.3 Item 7(Picture)

(3) The gutter system is in need of cleaning as some existing debris may slow the flow of water to the downspouts.

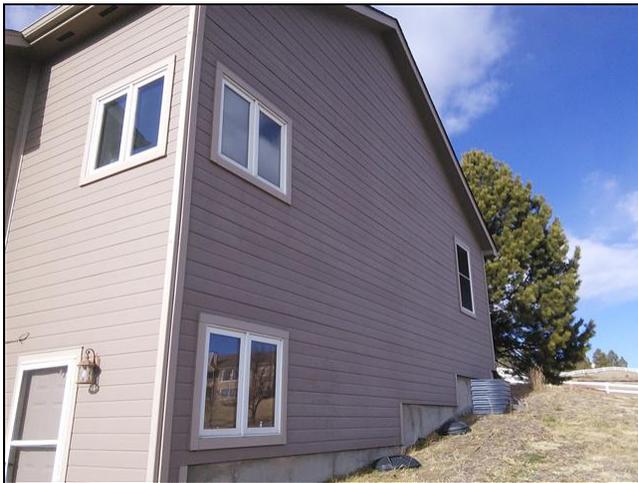
2.0 Item 1(Picture)

Portions of the home will require painting in the not too distant future, particularly on the east side of the home. There is evidence of oxidization, peeling, and failing caulk. Other areas of the home appear to have been repainted more recently.

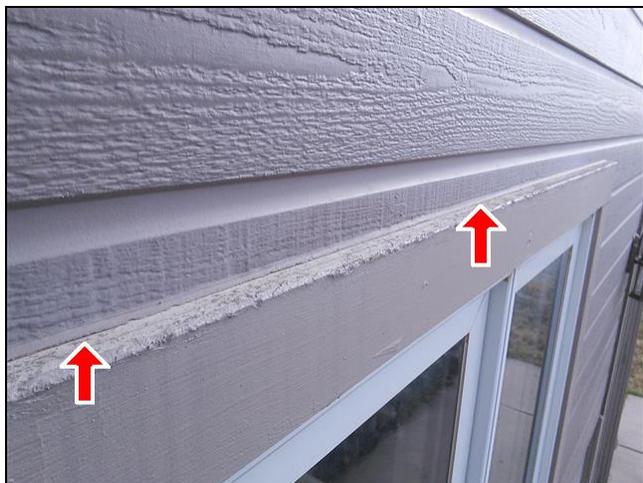
2.0 Item 4(Picture)

(2) The wall cladding, flashing, and trim appeared satisfactory and in serviceable condition. The trim work including the window trim was installed by the builder without the recommended Z-flashing. It is recommended that as part of a routine maintenance procedure this trim work be inspected, caulked, primed and painted as needed to ensure maximum life span of the materials.

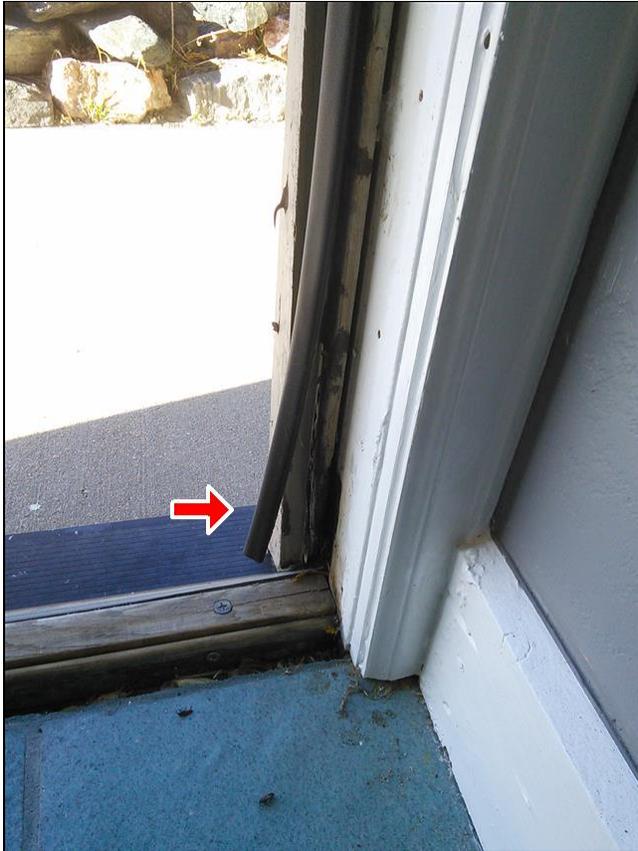
2.1 Item 1(Picture)

🔧 (2) Weather stripping at the rear of home, the basement office door, is in need replacement or adjustment to more adequately seal out weather.

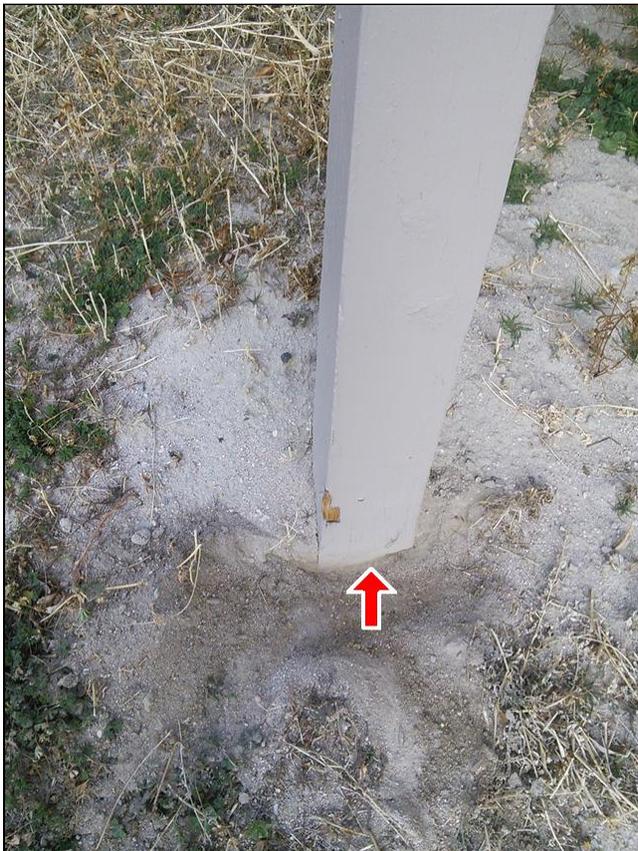
2.3 Item 1(Picture)

📍 (1) The deck at the west side of the structure had a post in direct contact with soil. This is commonly done if the wood member is a pressure treated type that can withstand moisture. It was not possible to ascertain if this wood was pressure treated or not. It might be recommended to inquire of the current resident as to the type of material used when installing this structural member.

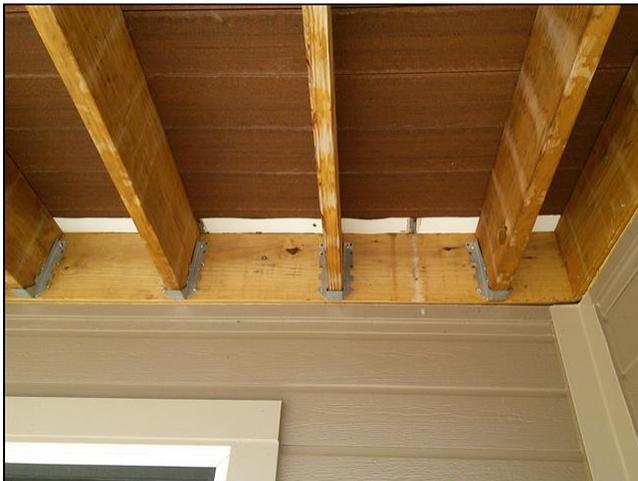
2.3 Item 3(Picture)

🏠 (3) The deck at the rear of home, accessible from master bedroom and kitchen area, appears to be somewhat unstable when lateral forces are exerted on it. The ledger board attachment cannot be confirmed as typical anchors are not visible. Additionally, the guardrail around this deck appears to be inadequate to protect individuals from potential fall hazard. It is recommend that this deck be evaluated and repaired, replaced, or reinforce by qualified contractor.

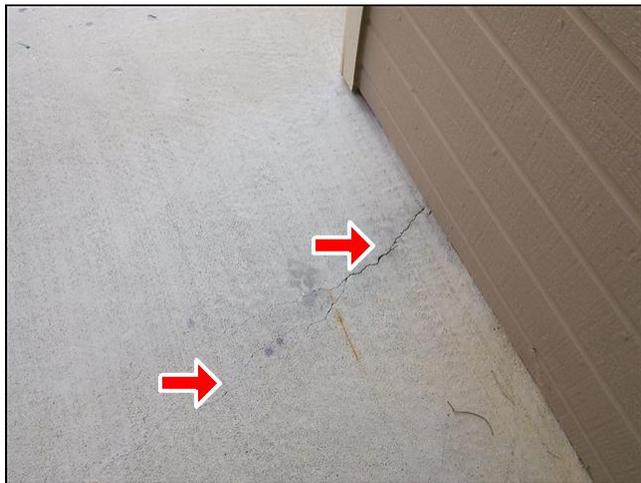
2.4 Item 5(Picture)

(2) Common cracks (1/4-inch or less) were visible in the front porch. Cracks exceeding 1/4 inch should be filled with an appropriate material to avoid continued damage to the concrete surface due to freezing moisture. Some modest movement of the soil beneath the front porch may be indicated. It is important to ensure that water from downspouts and run-off be directed away from the perimeter of the porch to help alleviate further settling.

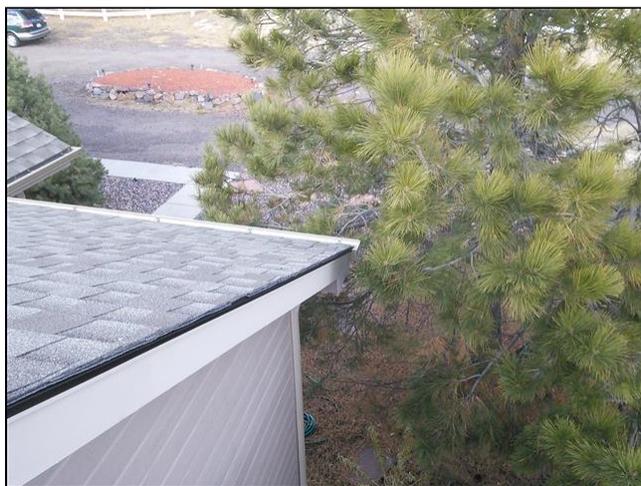
2.4 Item 6(Picture)

(3) Vegetation is typically not commented on by home inspectors unless there is a apparent or possible damage to the structure due to its location. It was noted that some trees are in contract or close proximity to roofing and/or siding materials which, particularly under windy conditions, could result in damage to roofing or siding. It is recommended that this be part of a routine maintenance program for trimming to ensure that it does not damage the structure.

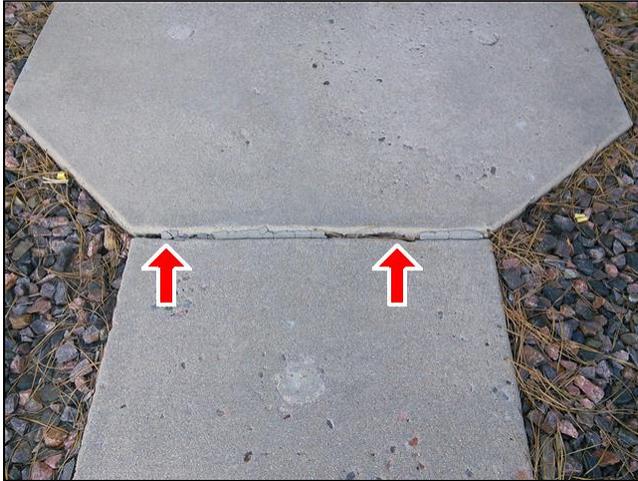
2.4 Item 7(Picture)

🏠 (4) Some settling of the walk way was noted. Settling of this nature (flat work) is typically not structural in nature. When these cracks are 1/4 inch or greater is is recommended to fill them with an appropriate sealant by a qualified technician.

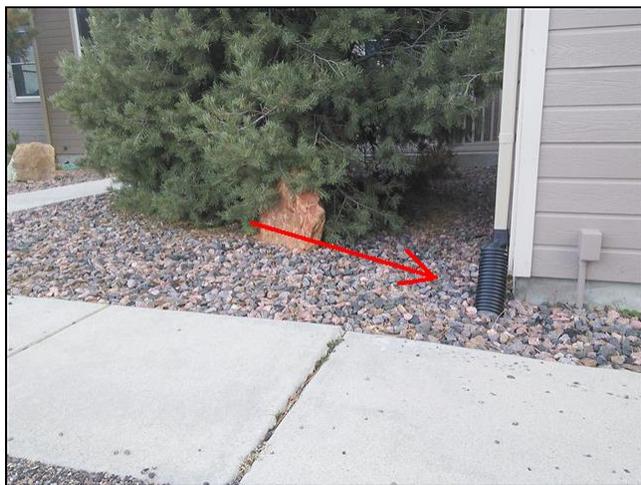
2.4 Item 10(Picture)

🏠 (5) By enlarge the drainage around the perimeter of the home appears to be adequate to move water away from the foundation. An area to observe over time is at the front of the home along side the garage. This area may have potential to hold moisture.

Also an area which may require more immediate attention is at the south side of the home by the back door in the south east corner. This area appears to allow moisture to collect and settle. The grading in this area can be improved to move water away. Also, there is a downspout with no extension at the same south east corner of the home. This should be extended to ensure water is not deposited in this area. (See section 1.3 #2 for further details)

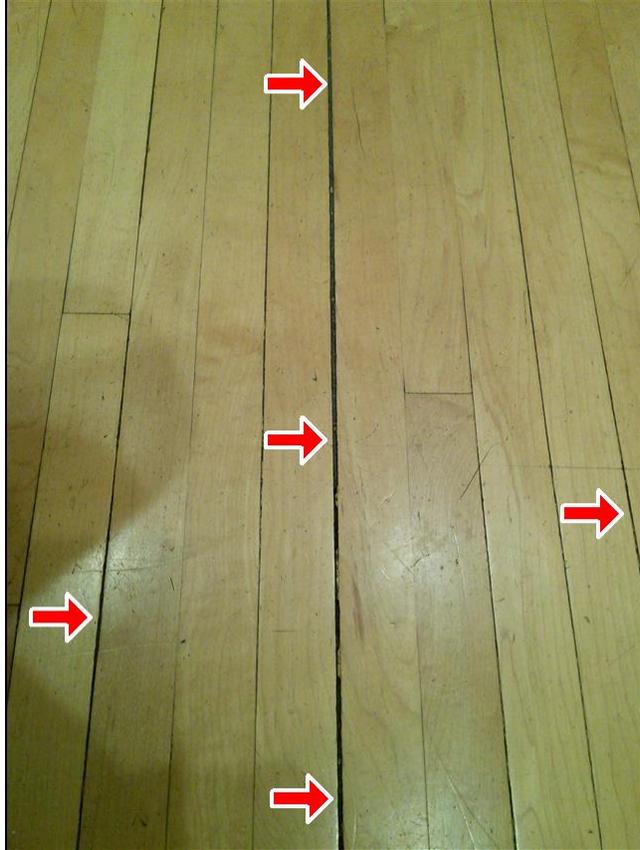
4.2 Item 1(Picture)

🏠 (1) At the time of the inspection, wood floors in various locations exhibited areas of moderate surface wear. Before the expiration of your Inspection Objection Deadline you may wish to consult with a qualified contractor to discuss options and costs for repair.

The wood floor in various locations had gaps visible at the time of the Inspection. This is usually due to shrinkage after installation and may be a sign of poor installation.

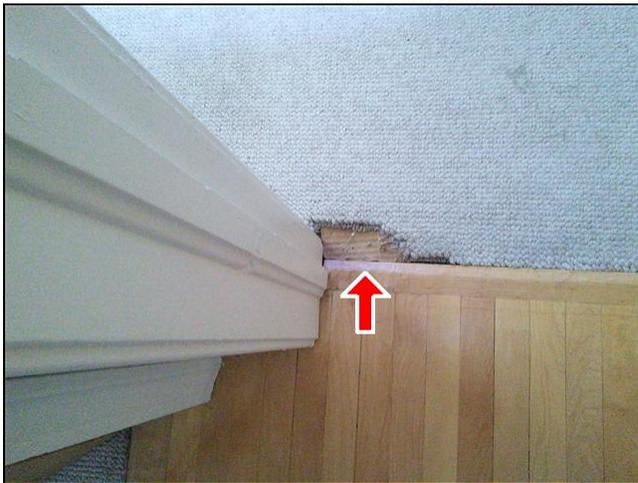
4.2 Item 4(Picture)

(2) The carpet at the 3rd bedroom on the first floor was damaged as shown in the adjacent image. It is recommended to repair as desired.

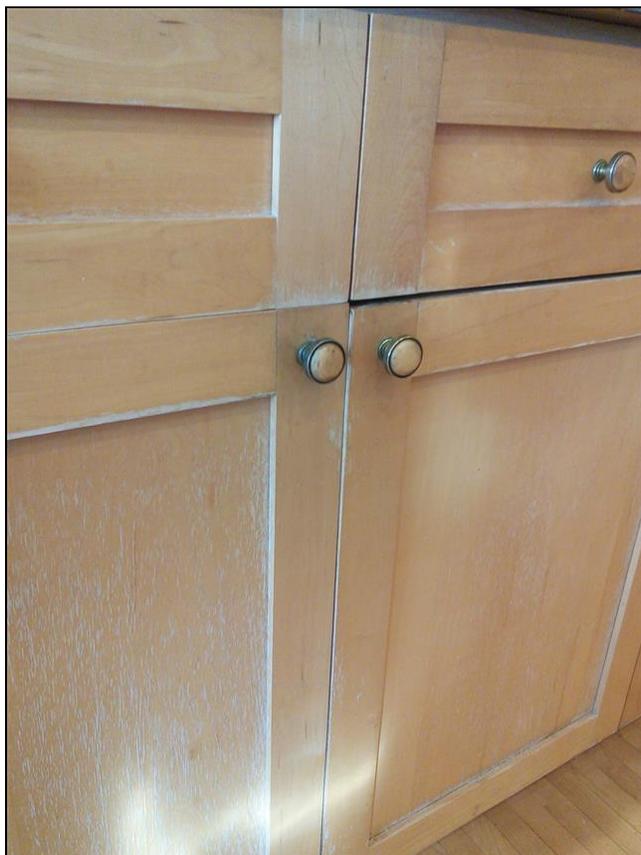
Several cabinet doors and drawers are in need of adjustment or repair. Some areas are in need of refinishing to protect the wood beneath. The carousel in the upper cabinet is beginning to wear and may need repair or replacement in the not too distant future.

4.4 Item 6(Picture) Damaged finish

You may want to consider consulting with a cabinet repair professional for information as to the cost of repair for these items prior to closing on the property.

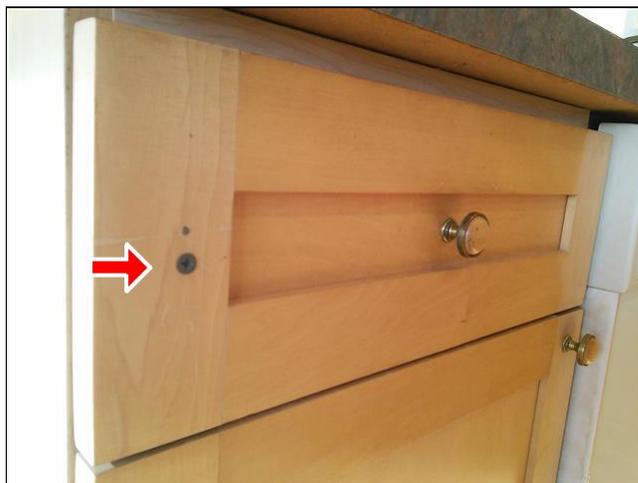
4.4 Item 7(Picture) Non standard drawer repair

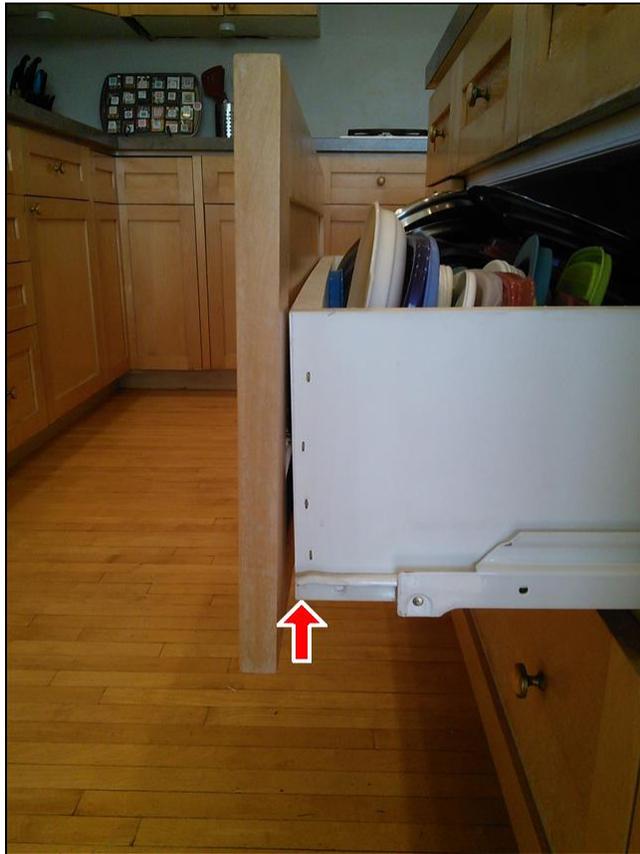
4.4 Item 8(Picture) Warped and loose drawer front

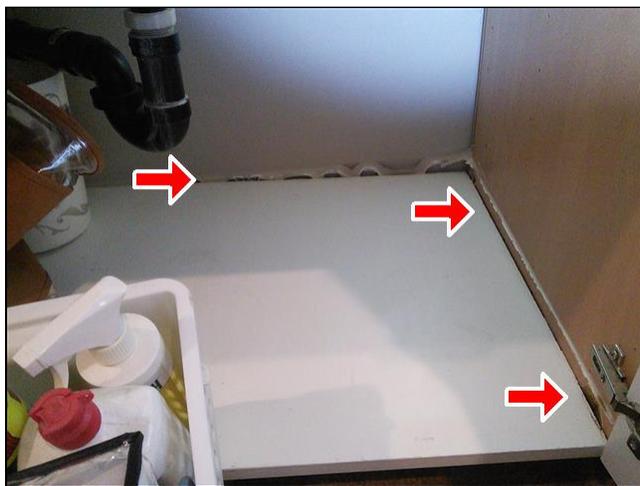
4.4 Item 9(Picture)

(3) The sink base cabinets in the laundry area is in need of repair or reinforcement. The base of the cabinet has come loose from the body. It is recommended to consult a cabinet repair professional for recommendations and cost of repair.

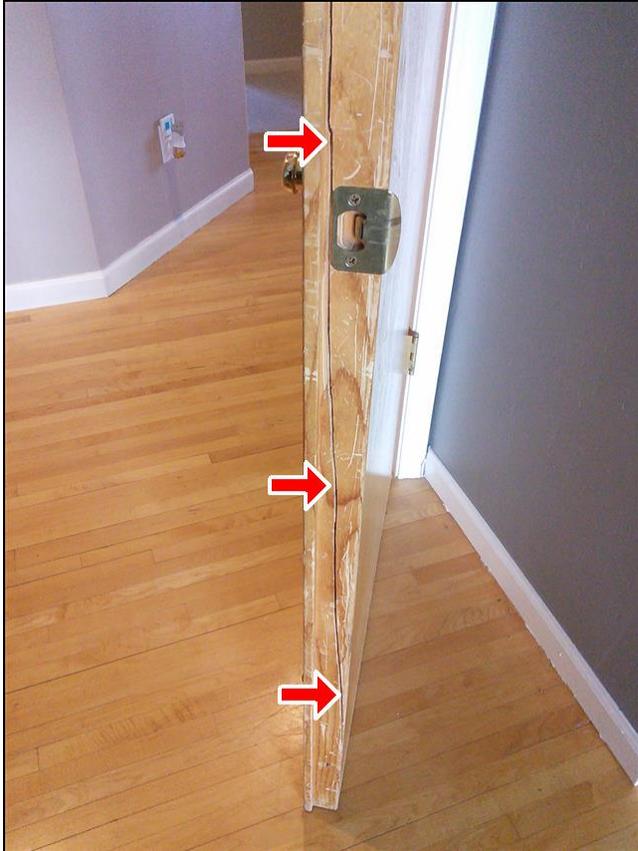
4.5 Item 1(Picture)

🏠 (1) The door at the master bedroom is damaged and in need of repair, note the crack noted by the arrows. It is recommended to consult with a qualified professional for repair or replacement.

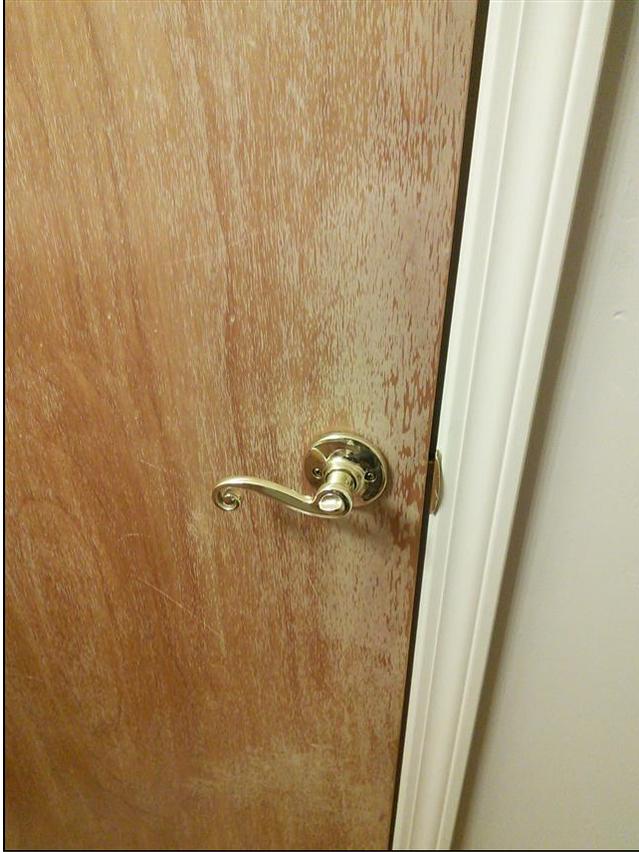
4.5 Item 2(Picture)

(2) Some doors, particularly in the bathrooms will need eventual refinishing.

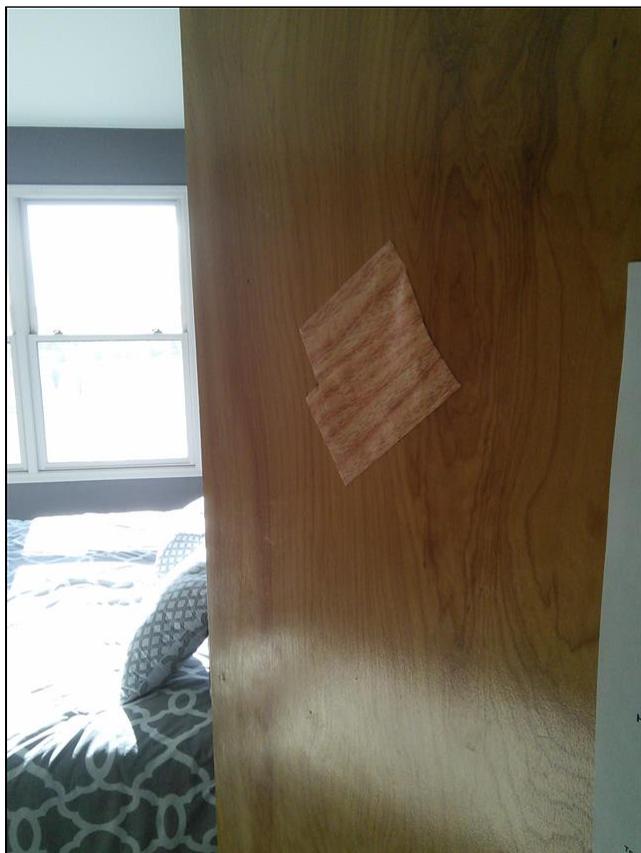
4.5 Item 3(Picture)

🏠 (4) The door to the basement bedroom appears to have had some damage and a non standard repair was made. It is recommended to repair or replace as desired.

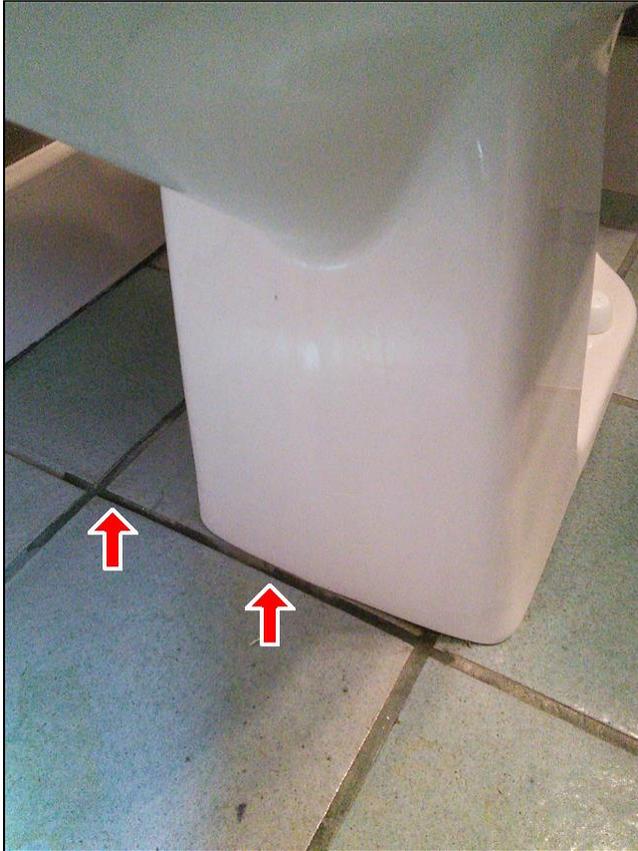
6.1 Item 11(Picture)

📍 (5) The toilet at the basement bathroom is not securely fastened to the floor. Small amounts of moisture was noted at the base presumably from the toilet drain. It is recommended that a qualified technician securely mount the toilet and ensure that there are no leaks.

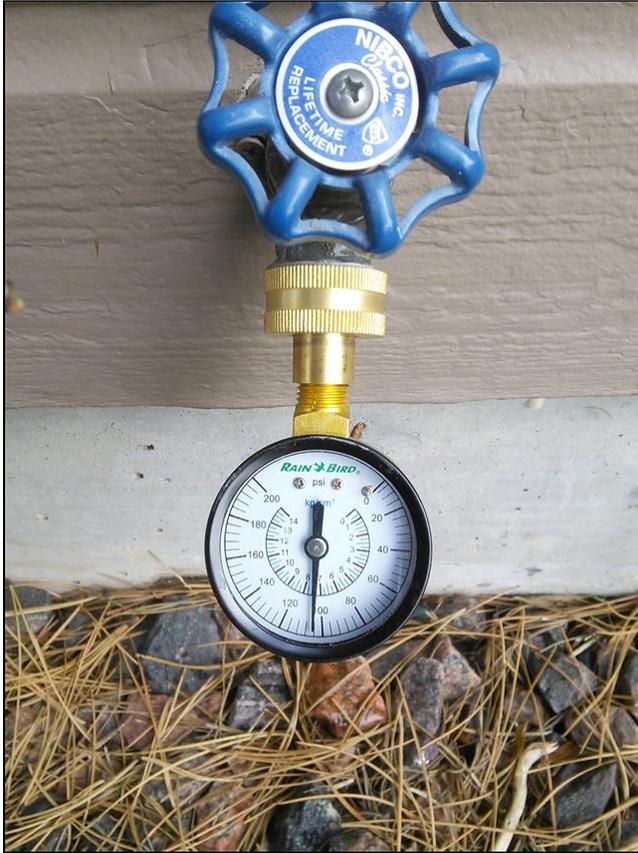
6.1 Item 12(Picture)

📍 (6) The water pressure as tested from an exterior hose bib is in excess of commonly accepted range of 40psi to 80psi. Excessively high water pressure can reduce the life of the water system including the fragile valves in dishwashers causing them to fail. It is recommended to adjust the water regulator if equipped or install a water regulator in the main incoming water line.

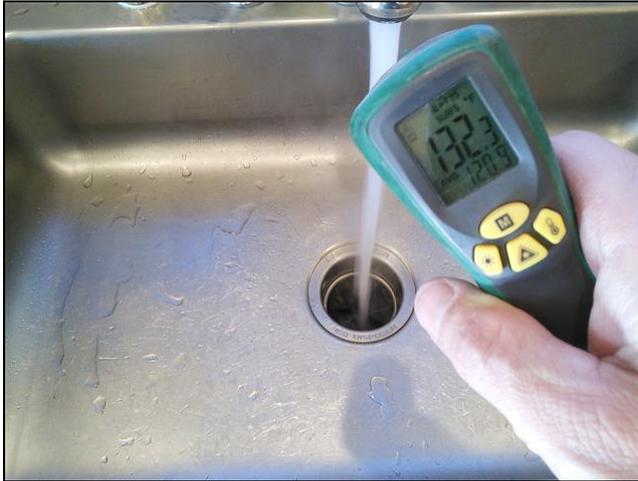
6.2 Item 1(Picture)

Water temperature was more than adequate. It is typically recommended to keep water temperatures at or below 120 degrees to avoid injury. This is especially important when there are children in the home. Recommend adjusting water heater temperature to more modest level.

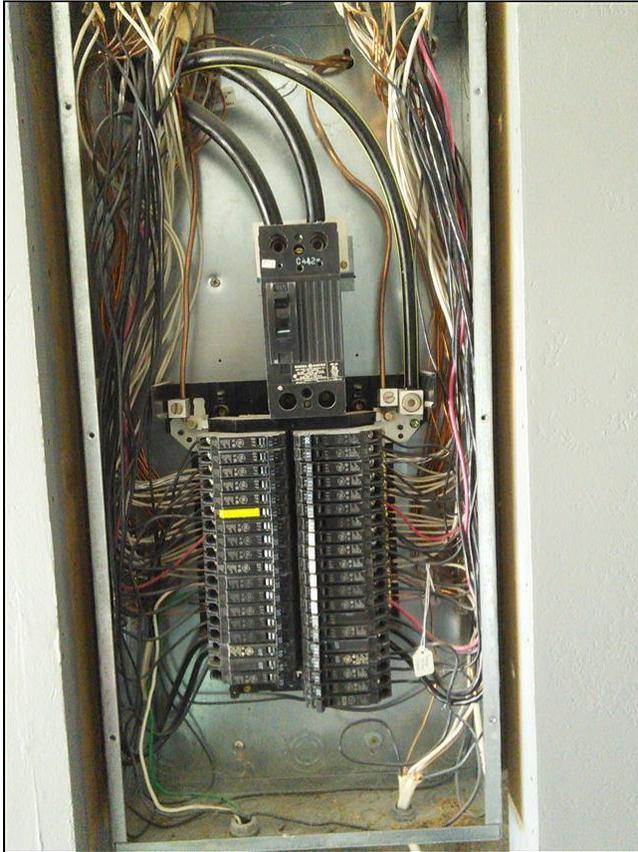
7.1 Item 1(Picture)

In the panel, two wires were connected to a single breaker designed for only one wire. This is known as a "double-tapping" or "double-lugging" and is a condition that should be corrected by a qualified electrical contractor.

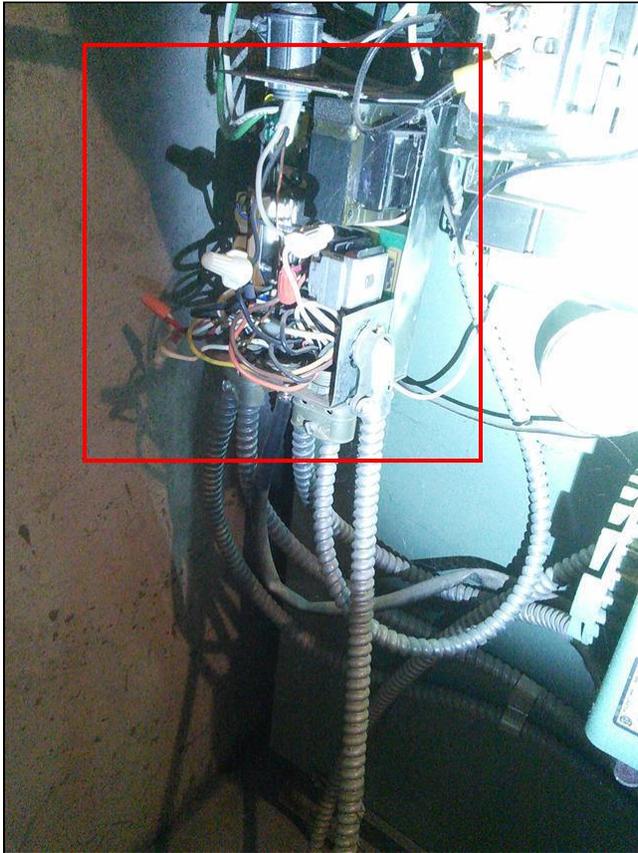
7.3 Item 1(Picture)

(4) Some exposed electrical connections were noted at the boiler in the unfinished portion of the basement. As this could cause electrical shock injury, it is recommended that the proper enclosure cover be installed at these locations by a licensed system repair professional.

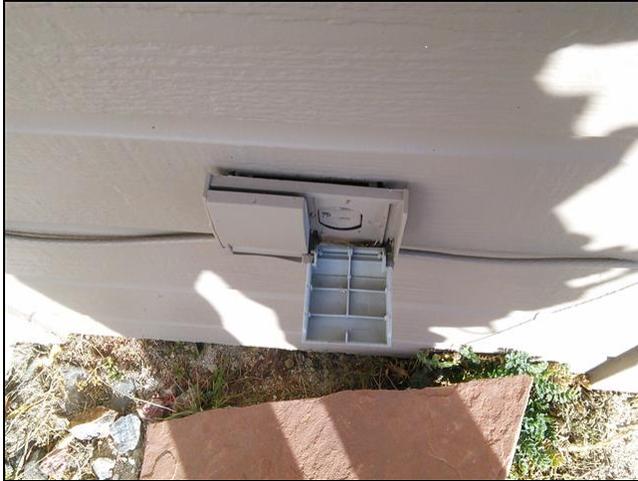
7.4 Item 1(Picture)

🏠 (1) The electrical receptacle enclosure at the exterior, south east corner of the home was damaged and in need of repair. It is recommended to consult with a qualified electrician for repair or replacement.

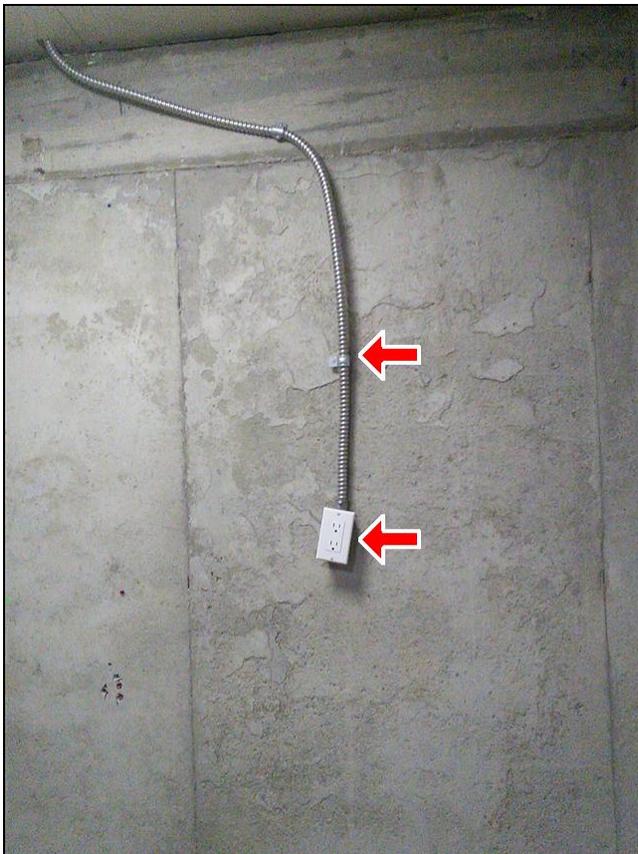
7.4 Item 2(Picture)

🏠 (2) A poorly mounted electrical receptacle was noted in the basement in what appears to be a safe room. It is recommended to have a qualified technician properly mount this fixture.

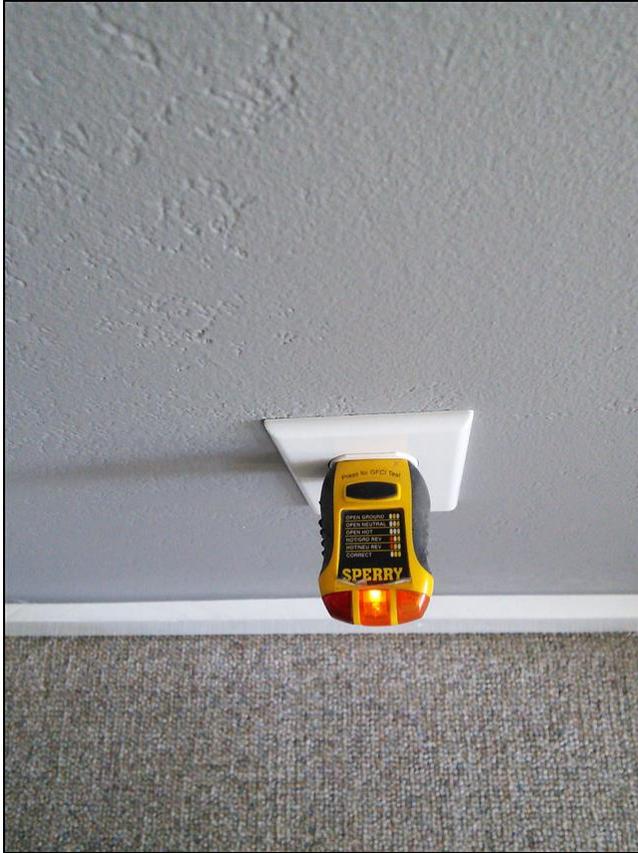
7.4 Item 3(Picture)

(3) An ungrounded receptacle was noted in the exercise room/office in basement. It is recommended to have this condition evaluated and repaired by a licensed electrician.

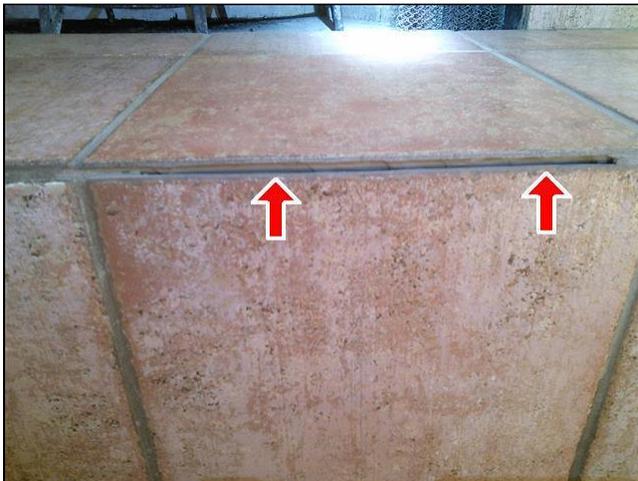
8.5 Item 2(Picture)

(2) The hearth at the wood burning fireplace had missing areas of grout. It is recommended to repair as desired.

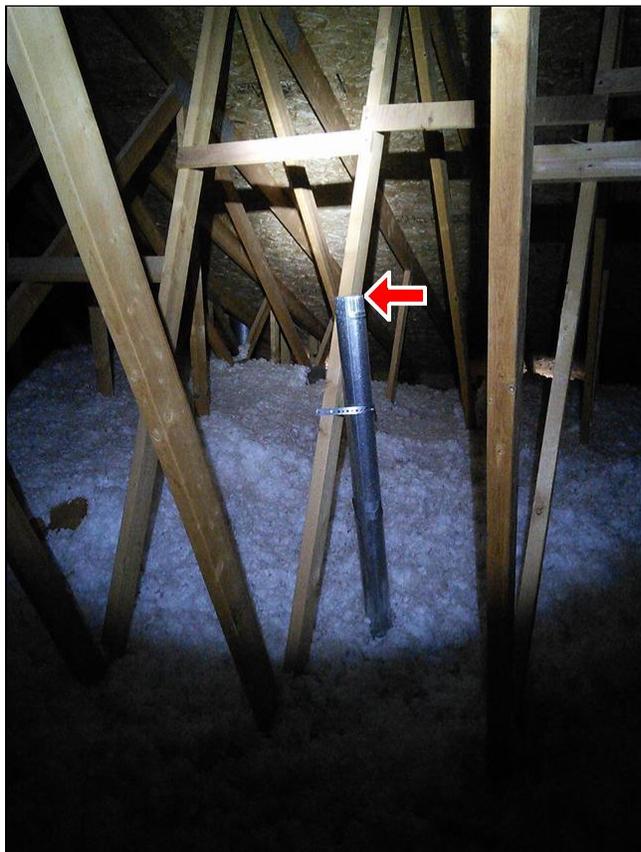
9.4 Item 1(Picture)

The bathroom exhaust fans that terminates in the attic space should be vented to the exterior of the building to help reduce moisture levels in the attic space. It is recommended that a qualified contractor extend the vent ducts to the exterior of the structure or up to the static roof vents.
