Inspection Report

Sample 2 Street

Denver CO 80126

Cozy Home Inspection Services LLC

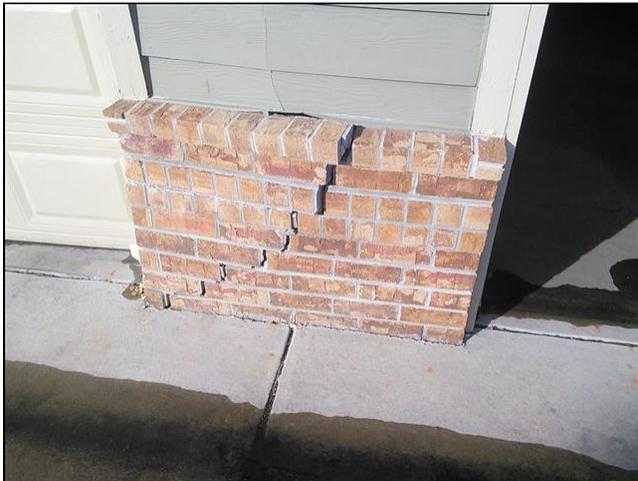
3.1 Item 1(Picture)

(2) The exterior wall and brick fascia of the garage has been damage and should be brought to the attention of the home owners association.

(2) The exterior wall and brick fascia of the garage has been damage and should be brought to the attention of the home owners association.

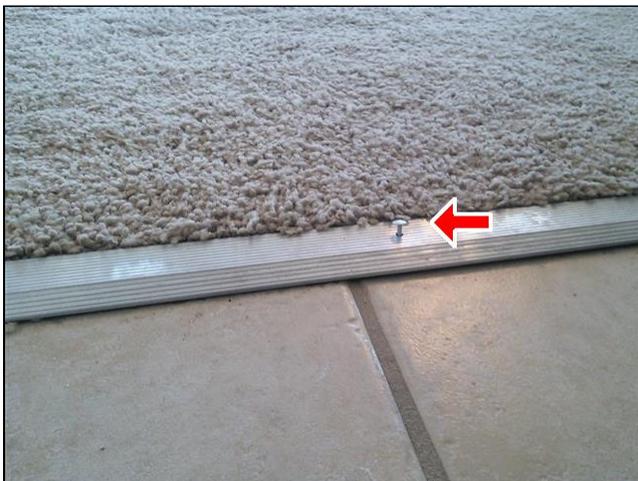
4.2 Item 1(Picture)

(2) The carpet threshold from the entryway to the living space requires repair or replace. The fasteners are backing out and present a trip or injury hazard.

(2) The carpet threshold from the entryway to the living space requires repair or replace. The fasteners are backing out and present a trip or injury hazard.

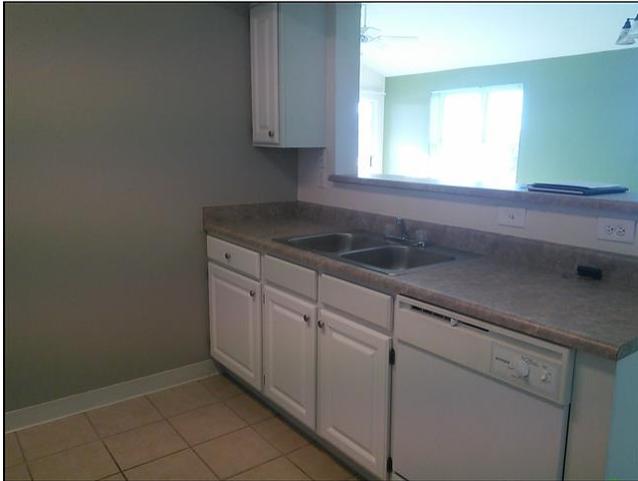
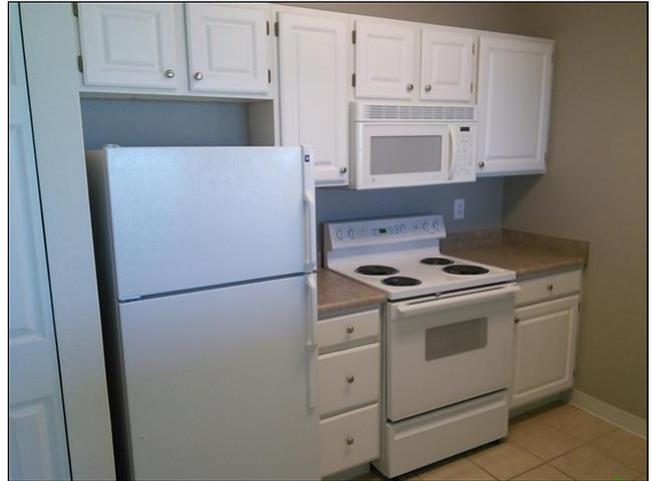
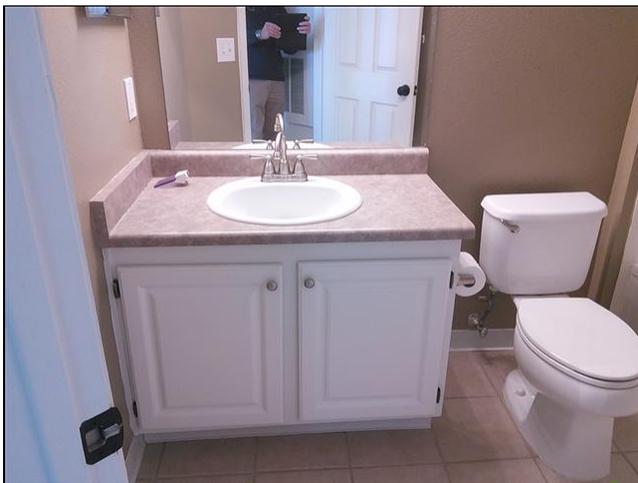
4.4 Item 1(Picture)

The counters and cabinets appeared to be in serviceable condition.

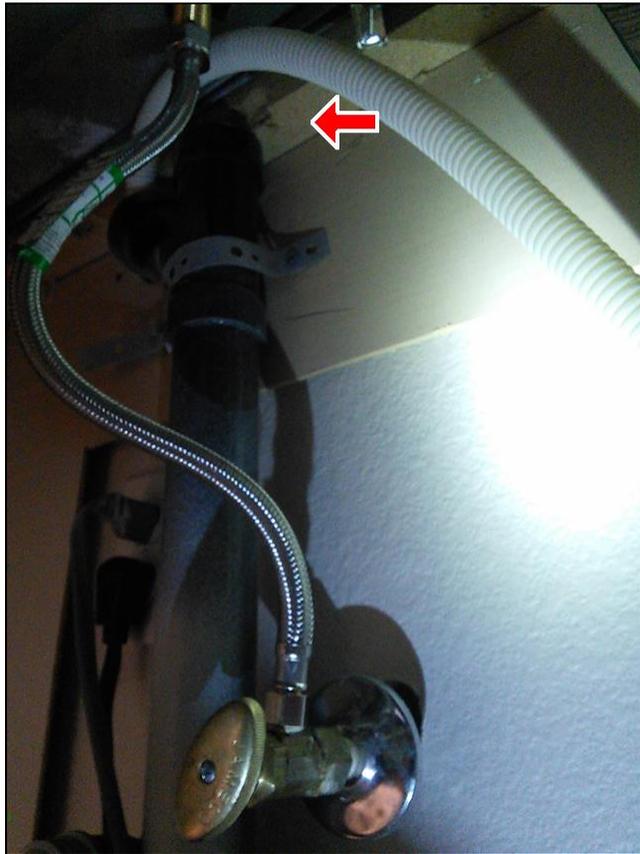
6.1 Item 1(Picture)

(2) Plumbing venting under the kitchen could benefit from an air admittances valve if clogging and overflow become an issue. This would also require a different form of dishwasher drainage and require installing with a air gap or high loop. (see adjacent images)

- Connect to a disposer dishwasher drain connection (25b).

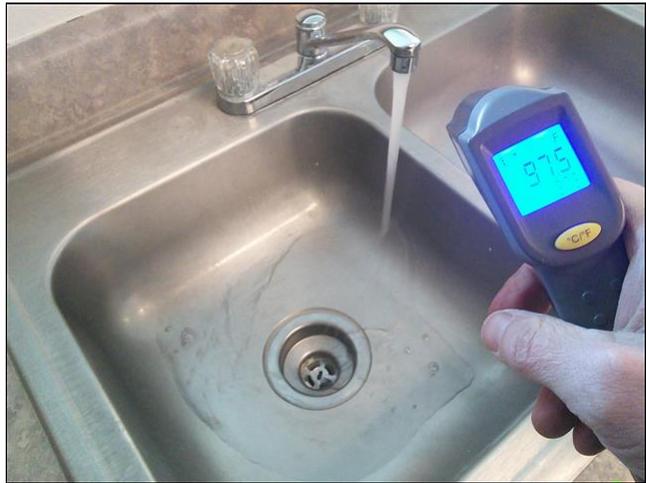
6.2 Item 1(Picture)

(1) Hot water temperature appears to be adequate and within reasonable expectations. Measurements indicated approximately 100 degrees at fixtures.

Water heater data plate:
 Model: MIXR504T6EN10
 Serial: TF5764494
 Manufactured: 6/1999

(2) There appears to be a natural gas leak at the water heater. This should be inspected and repaired as soon as possible by a qualified technician.

(2) There appears to be a natural gas leak at the water heater. This should be inspected and repaired as soon as possible by a qualified technician.

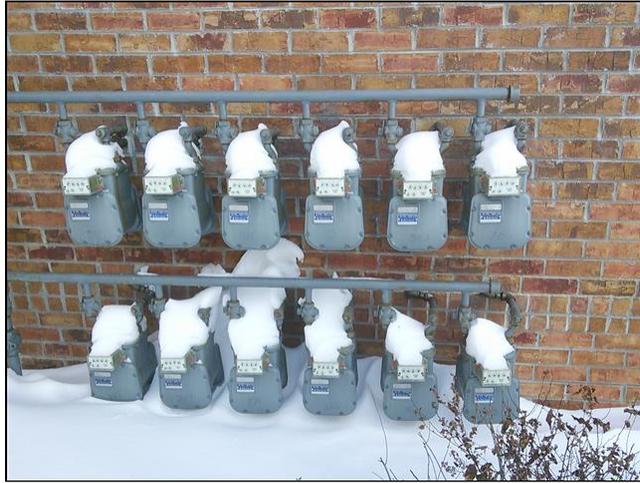
6.4 Item 1(Picture)

The main gas shut-off valve is located outside on the north east side of the structure. All the gas valves for the building and it's various units are located in this location but are not labeled. This information should be available from the home owners association.

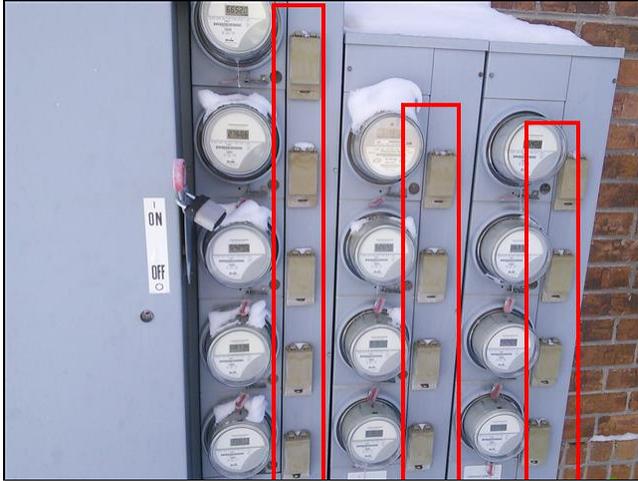
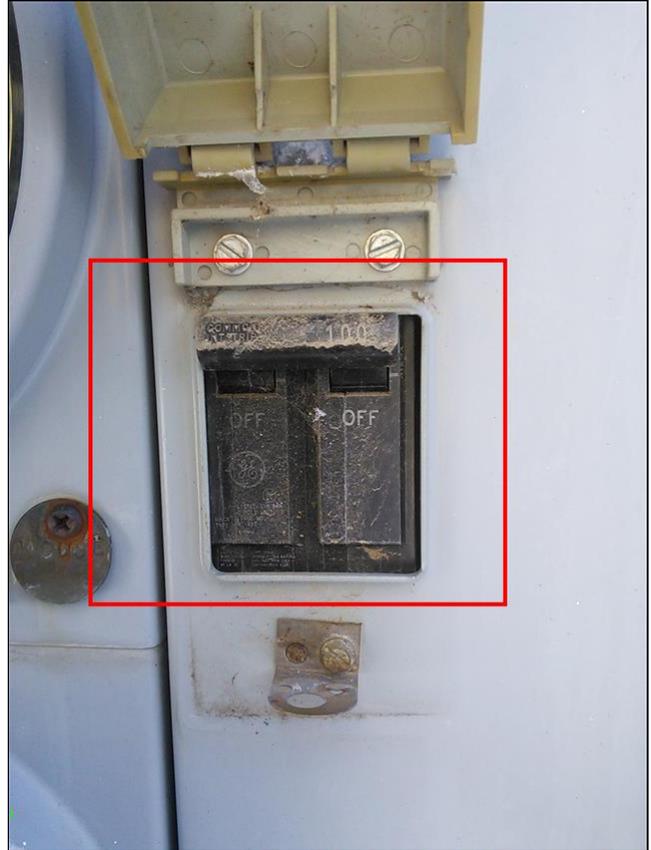
7.6 Item 1(Picture)

The distribution panel is located in the utility closet, but it should be noted that the main breaker is located on the south east exterior wall of the building. There are individual main breakers for each unit located here but are not individually labeled (as indicated by the adjacent images). This information should be available from the home owners association.

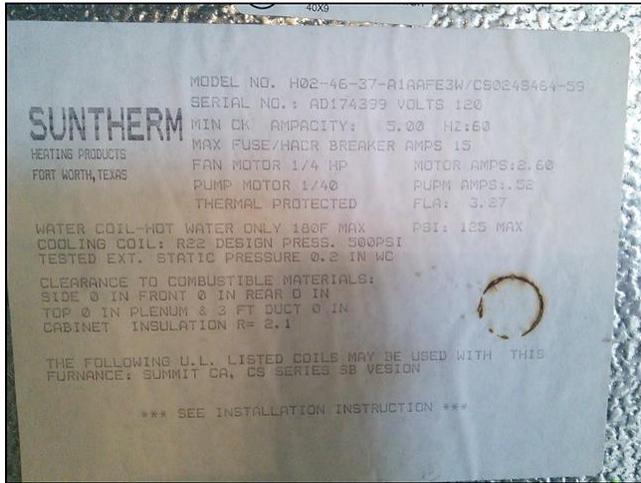
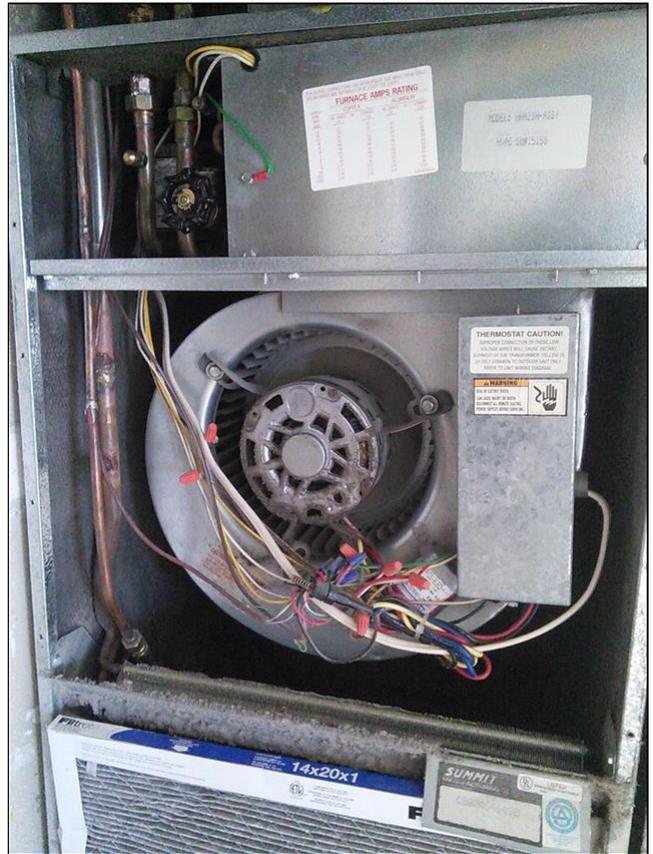
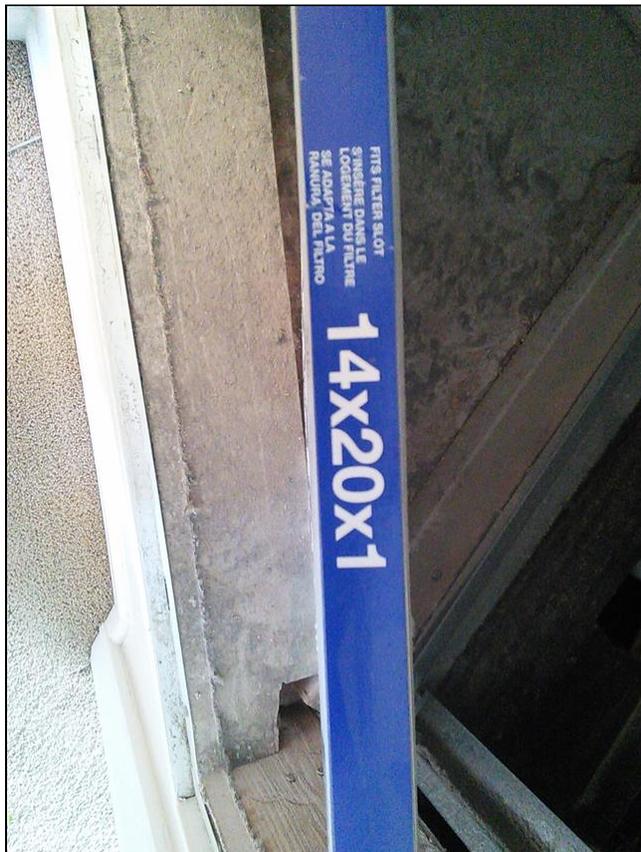
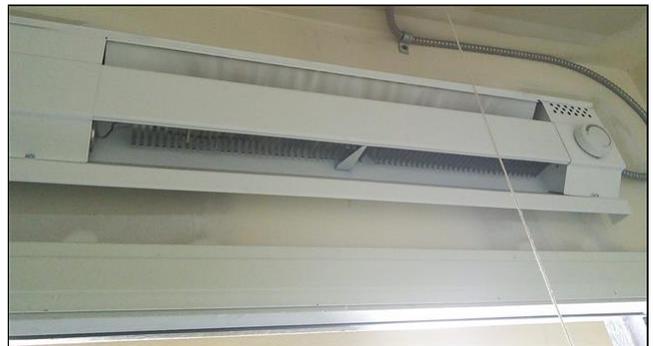
8.0 Item 1(Picture)

Manufactured: Appears to be 1999 although exact manufacture date is not available.

There is also a radiant electrical heating unit in the storage closet. Be cautious not to store items close to this unit, particularly flammable materials.

(2) It is generally recommended by the manufacture to have your heating system serviced each year. The hot water heating system (hydronic system) in this home does not appear to have been serviced recently and is in need of cleaning. It is recommend that the system be inspected, cleaned, and serviced by a qualified HVAC specialist.

The air filter in this unit is in need of replacement and should be inspected by the home owner ever 2 or 3 months.

The air filter in this unit is in need of replacement and should be inspected by the home owner ever 2 or 3 months.

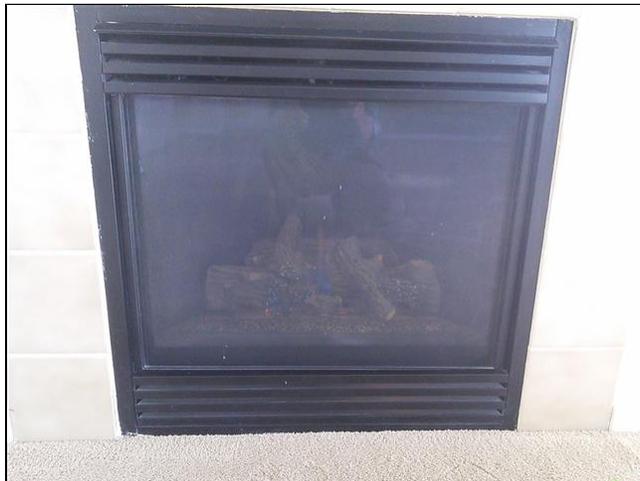
8.7 Item 1(Picture)

The gas fireplace was operational and in serviceable condition.

Recommend service and cleaning by qualified technician to improve performance and efficiency.

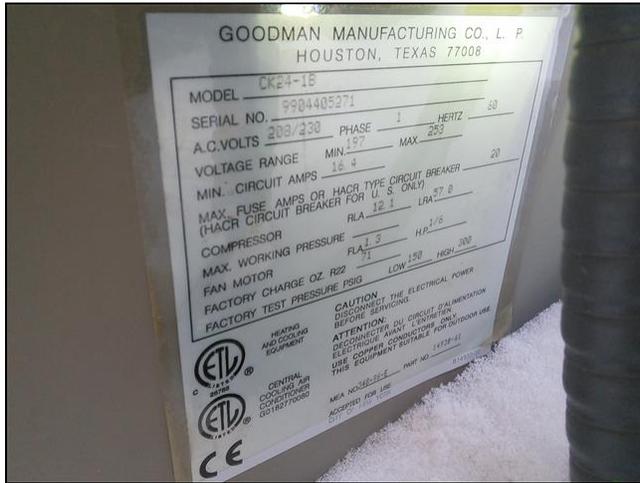
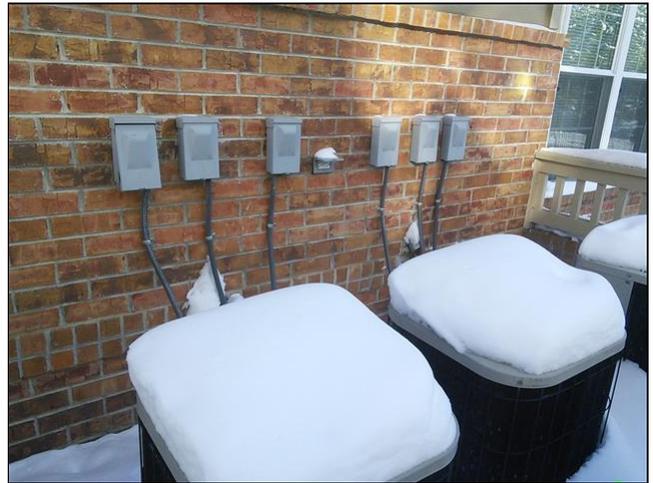
8.8 Item 1(Picture)

All AC units for each housing unit are clustered together on the east side of the building and not labeled to indicate which residence they are associated with. For this reason the images provided were taken from one of the AC units and may not be the exact unit servicing your residence. As all units appear to be the same type it is expected that the manufacture date should be accurate.

AC unit data plate:
Model: CK24-1B
Serial: 9904405271
Manufactured: 4/1999

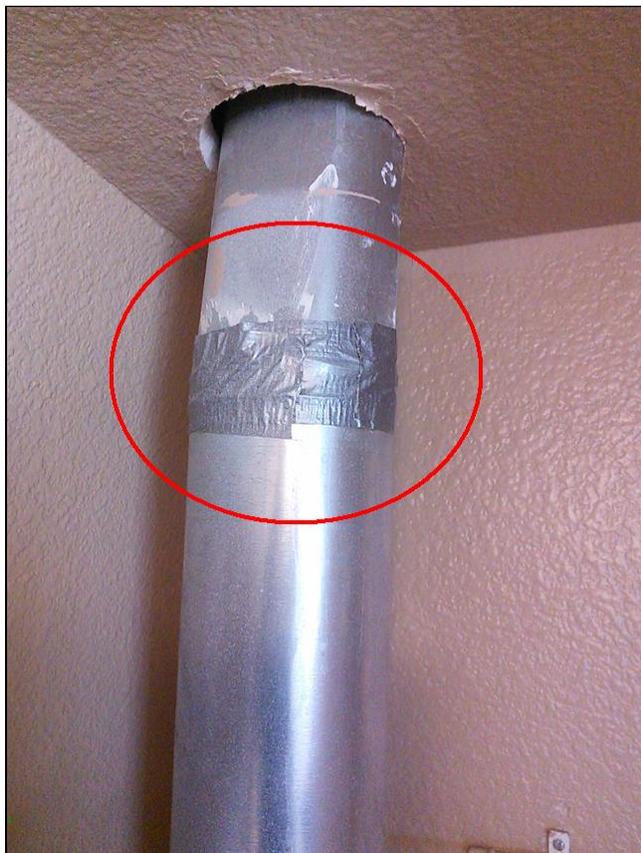
9.4 Item 1(Picture)

(2) The dryer vent ducting sections are connected using non-standard materials (duct tape). General rules for joining sections of dryer vent ducting are as follows:

- Duct joints shall be installed so that the male end of the duct points in the direction of the airflow.
- Joints should be secured with metal tape (not duct tape)
- Do not use rivets or screws in the joints or anywhere else in the duct as these will encourage lint collection.

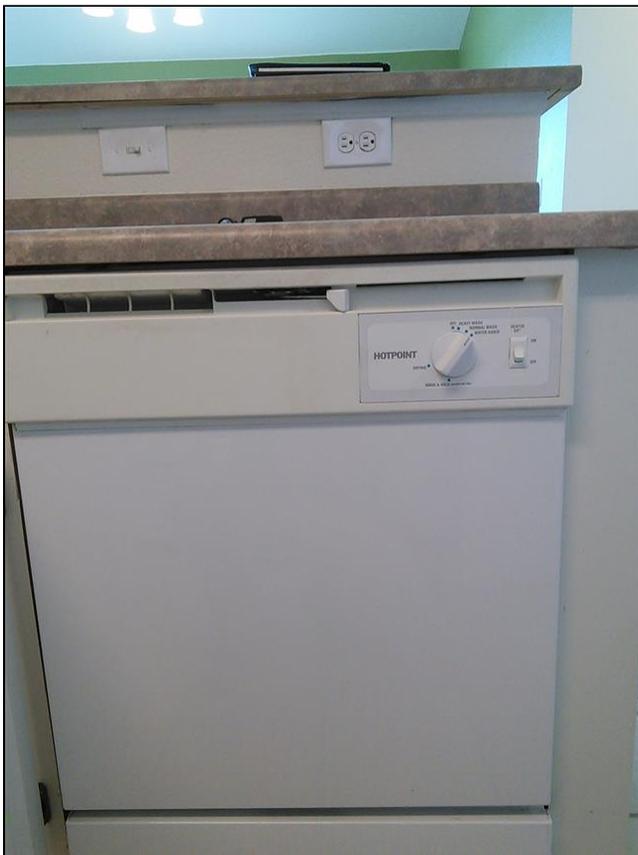
10.0 Item 1(Picture)

The dishwasher was run through a partial cycle to check for general operation including hot and cold water use, soap tray operation, discharge pump operation, and existence of leaks. Although no leaks were detected, access to the underside of the equipment was limited allowing for limited visibility.

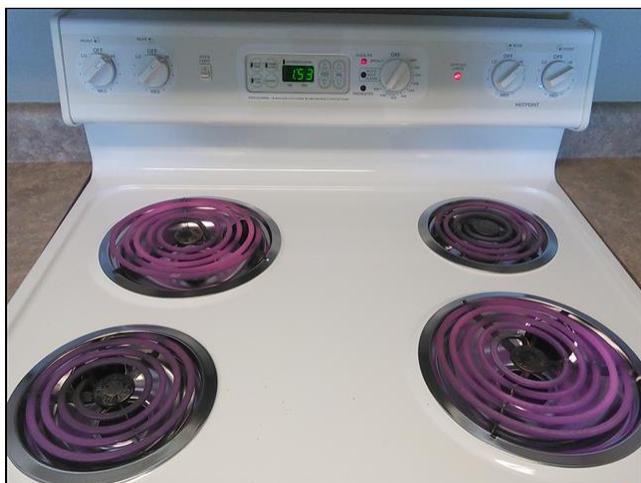
10.1 Item 1(Picture)

The oven, broiler, and cook top appear to be in serviceable condition.

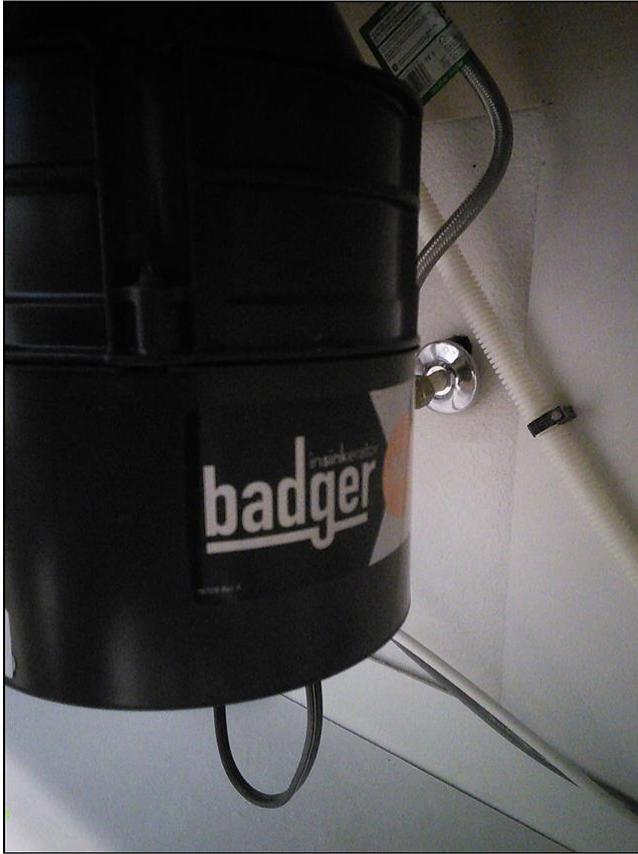
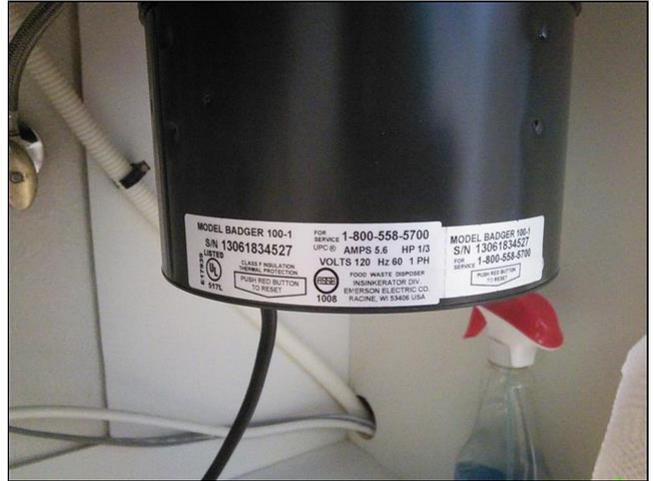
10.4 Item 1(Picture)

The food waste disposer was in serviceable condition at time of inspection.
Serial number noted in image.

Model: Model 100ss
Serial: 13061834527
Manufactured: 6/2013

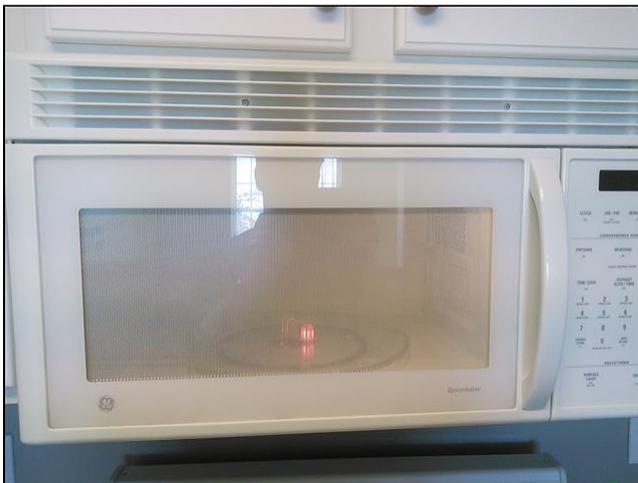
10.5 Item 1(Picture)

The microwave oven appears to be malfunctioning and requiring replacement or repair. During operation it appears to short electrically and noticeable electrical burning smell is detectable. It is recommended that the unit not be operated until repaired or replaced by a qualified technician.

The microwave oven appears to be malfunctioning and requiring replacement or repair. During operation it appears to short electrically and noticeable electrical burning smell is detectable. It is recommended that the unit not be operated until repaired or replaced by a qualified technician.

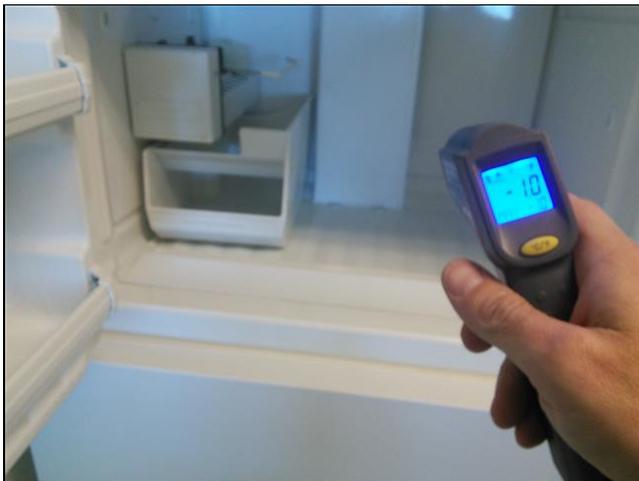
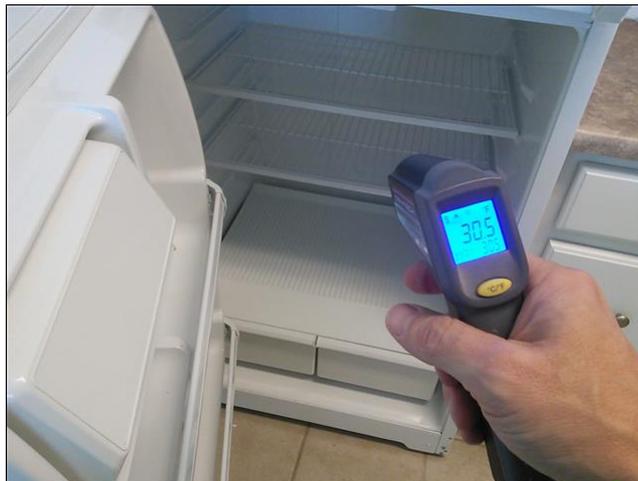
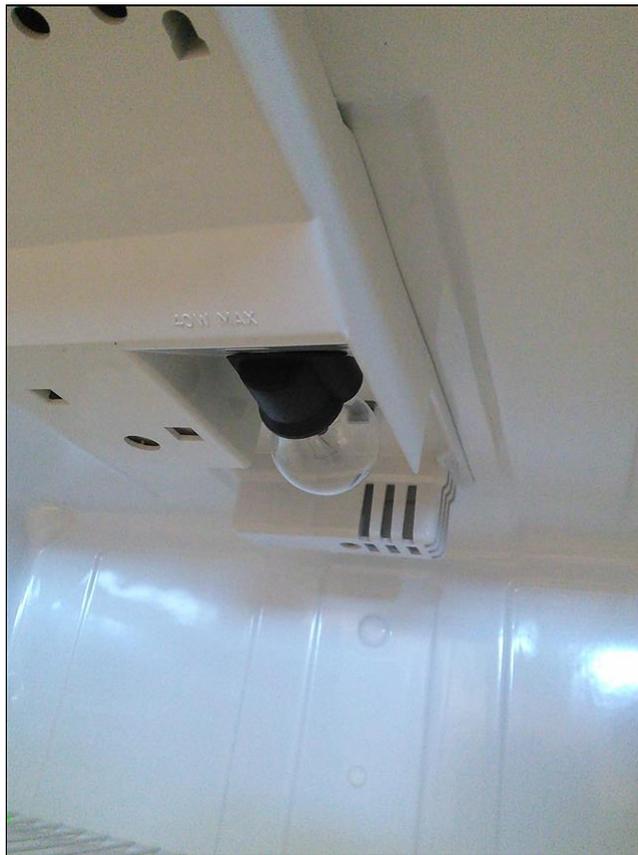
10.6 Item 1(Picture)

The refrigerator and freezer appear to be in serviceable condition as noted by the adequate cooling temperatures.

Note: The refrigerator light was not operable at time of inspection, recommend repair or replace of bulb.
