Residential Property Inspection Services

Inspection Report

Property Address:
1000 Rock River Rd
Denver CO 80000

Cozy Home Inspection Services LLC

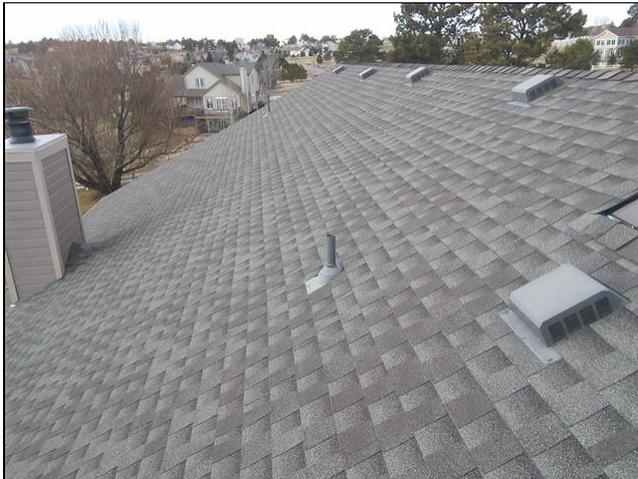
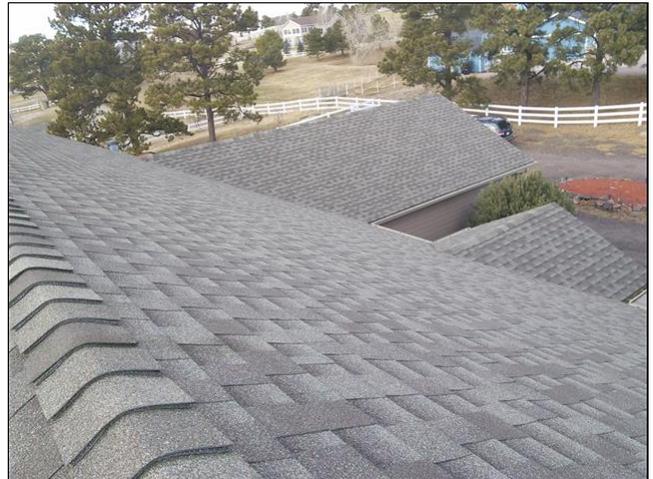
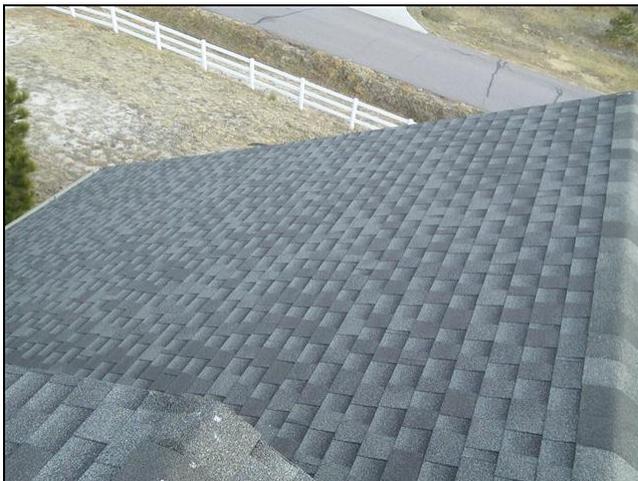
The roof covering material is in a condition that is consistent with its age and method of installation, showing no major deficiency or cause for immediate concern.

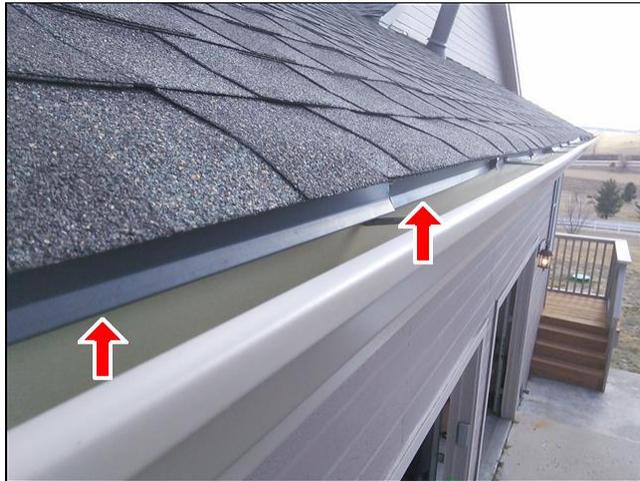
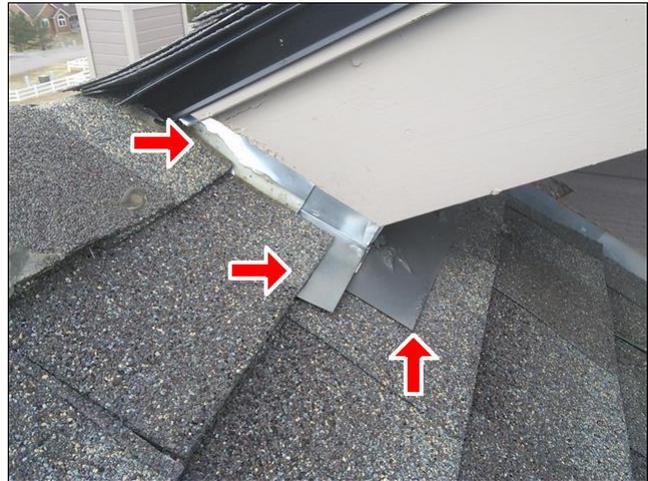
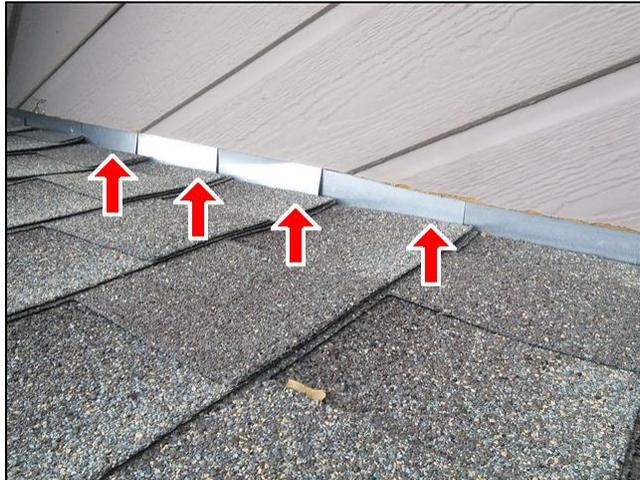
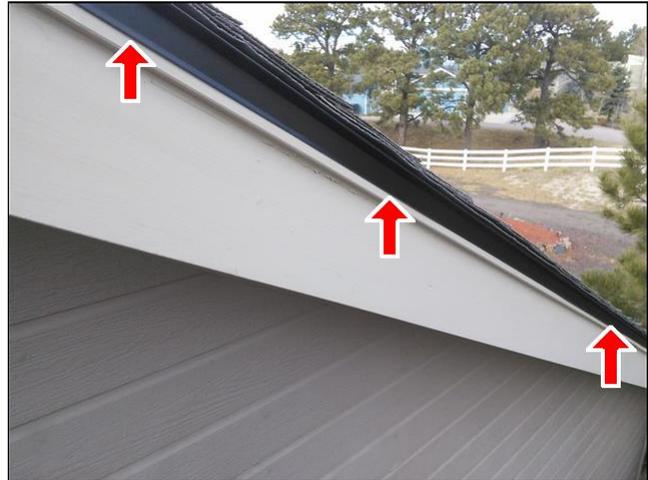
(1) Appropriate step flashing, trim flashing, and fascia flashing was present and appeared to be in serviceable condition.

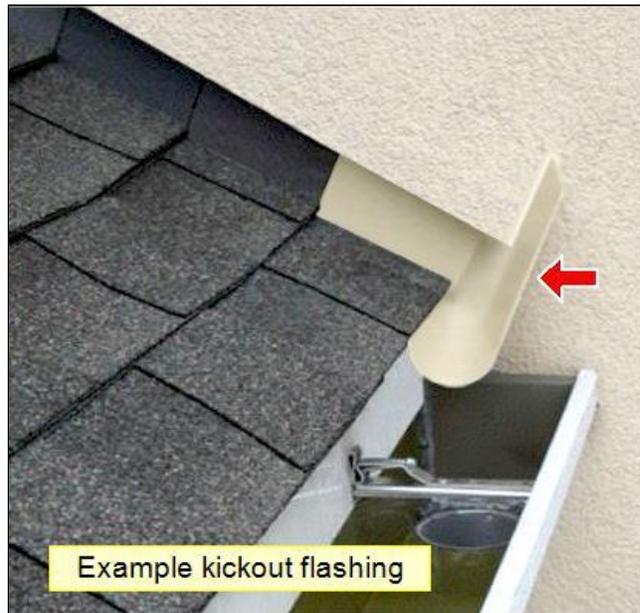
1.1 Item 6(Picture)

🏠 (2) There are areas that would benefit from kickout flashing installation. (see the image titled "Example of kickout flashing" below) Kickout flashings are recommended where a roof and exterior wall intersect so as to divert water away from the wall cladding and into a gutter. When properly installed they can provide excellent protection against the penetration of water into the building envelope. It is recommended to consult with a roofing specialist with regard to evaluation and installation of this flashing material.

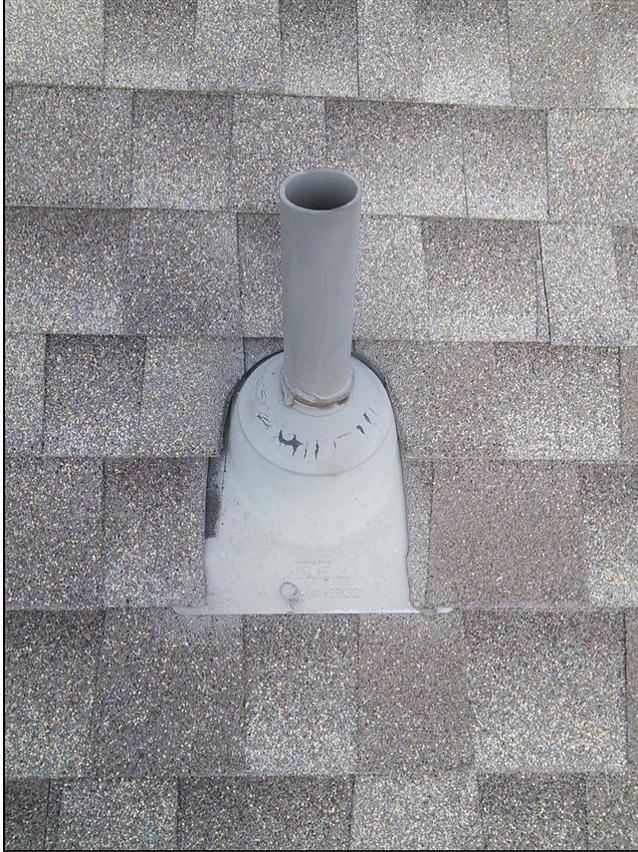
1.2 Item 1(Picture)

The roof penetration flashing appear to be in place, caulked and watertight as observed from the roof.

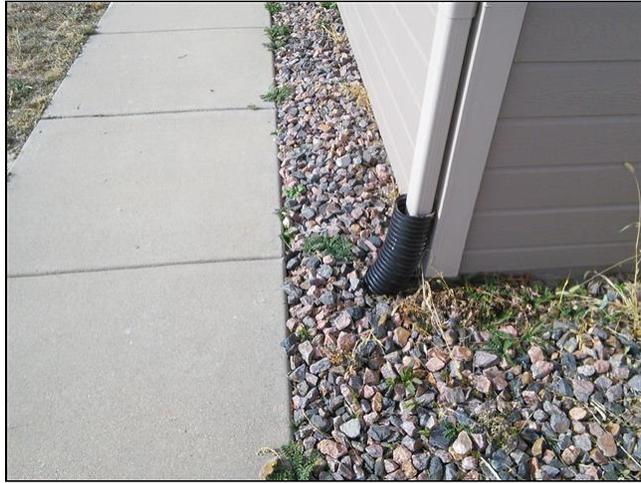
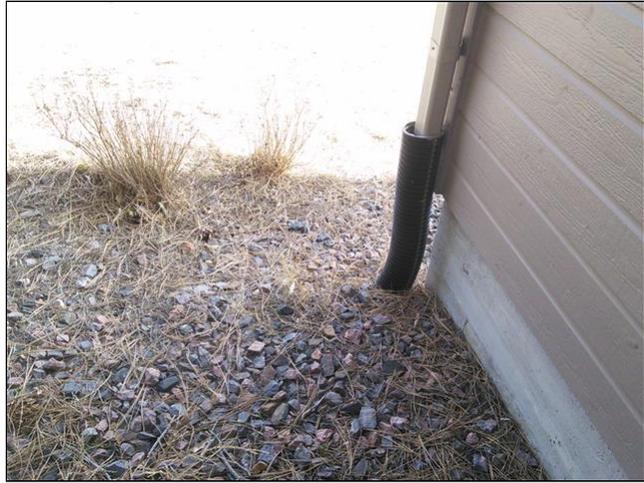
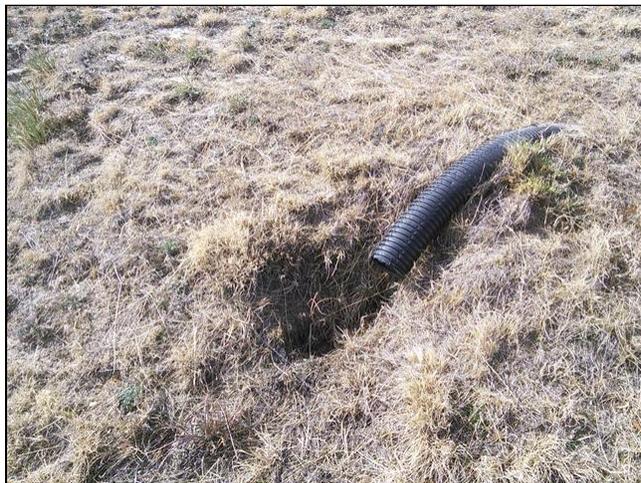
🏠 (1) The gutter system on the roof edge appears to be functional and appear adequately sloped to carry the water to the downspouts.

Note: Downspouts that terminate underground, presumably draining to daylight, were not fully visible making it impossible to determine if drains will function properly under load.

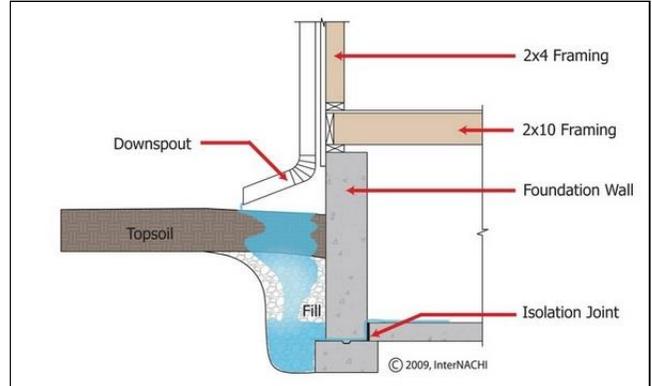
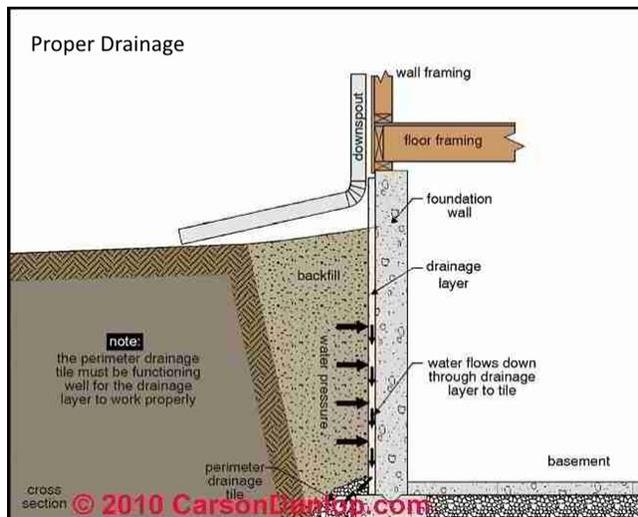
🏠 (2) At least one downspout extension is disconnected and should be serviced. All downspouts should be extended well away from the foundation. Recommend a qualified person install missing downspout extensions.

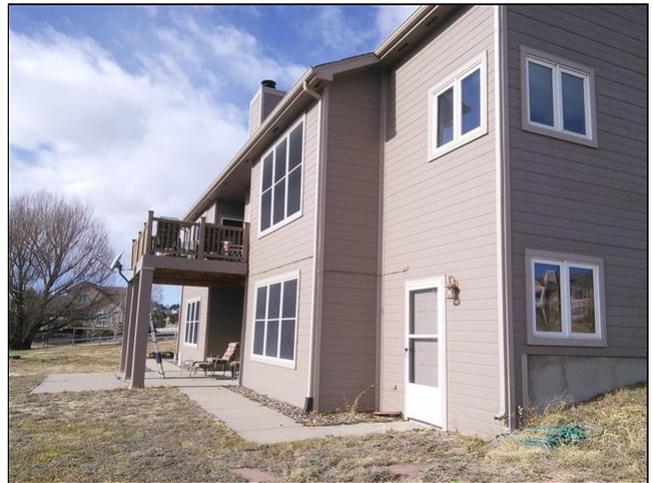
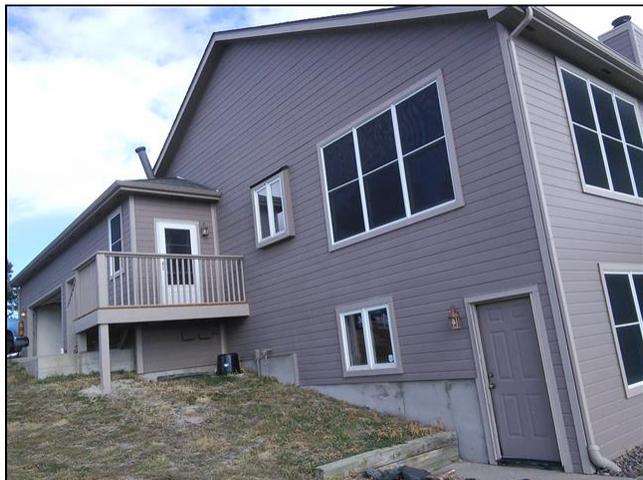
Portions of the home will require painting in the not too distant future, particularly on the east side of the home. There is evidence of oxidization, peeling, and failing caulk. Other areas of the home appear to have been repainted more recently.

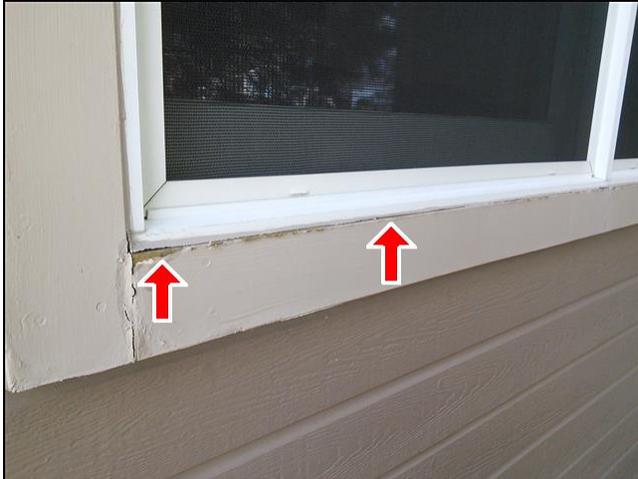
2.2 Item 1(Picture)

The windows as viewed from the exterior of the home appeared satisfactory and in serviceable condition, although a few windows would benefit from exterior sealing, prime, and paint..

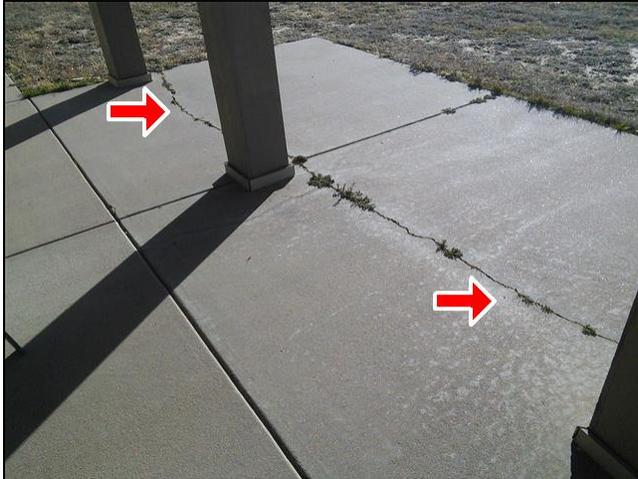
2.3 Item 2(Picture)

🏠 (2) The rear porch had some cracking and settlement, but was in usable condition. Ensuring proper drainage as well as appropriate sealing of cracks would be beneficial and is recommended.

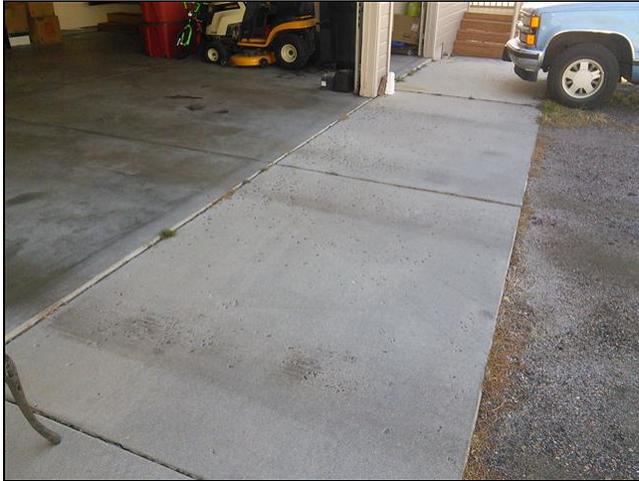
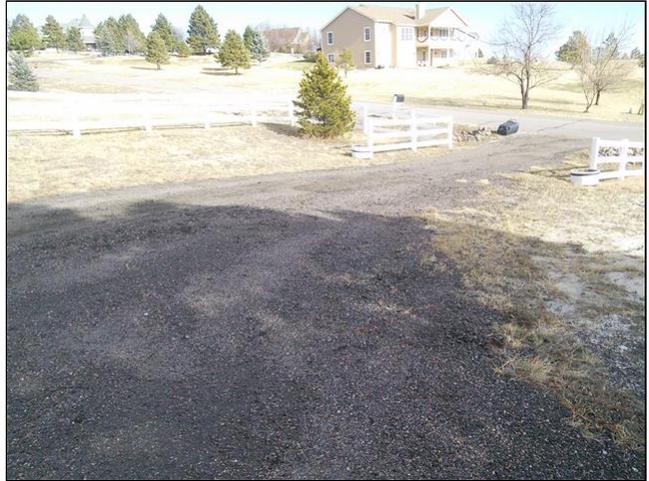
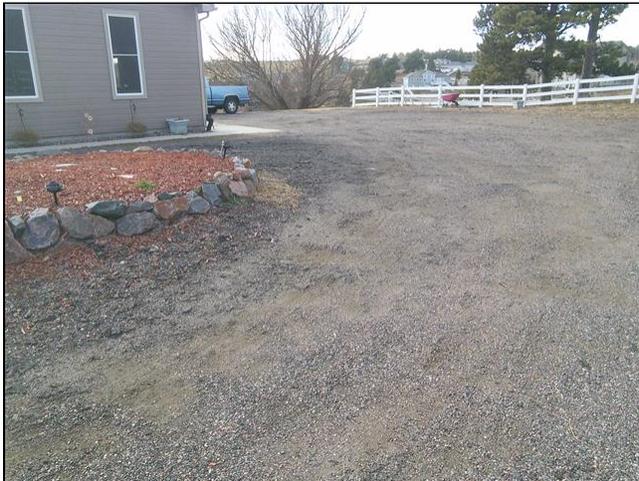
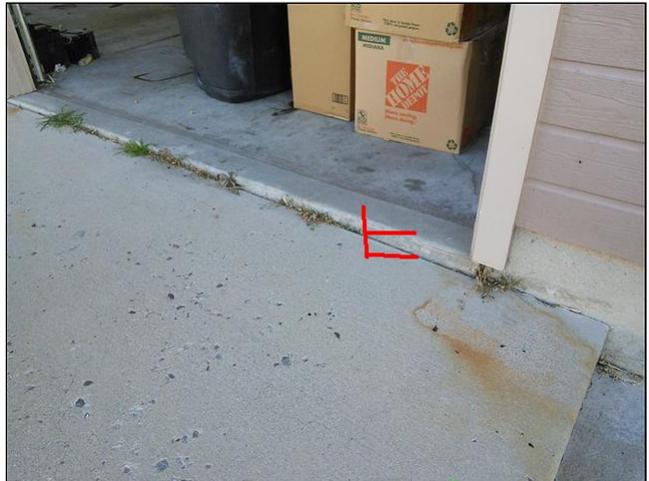
An area of note is the concrete slab in front of the single car garage door which has settled 2-3 inches. This is a common problem in the Denver area as we have expansive soils. This can be alleviated to some degree by ensuring that water drains away from the home and that no downspouts are depositing water in the area.

This is a condition that may be observed over time to determine if action needs to be taken.

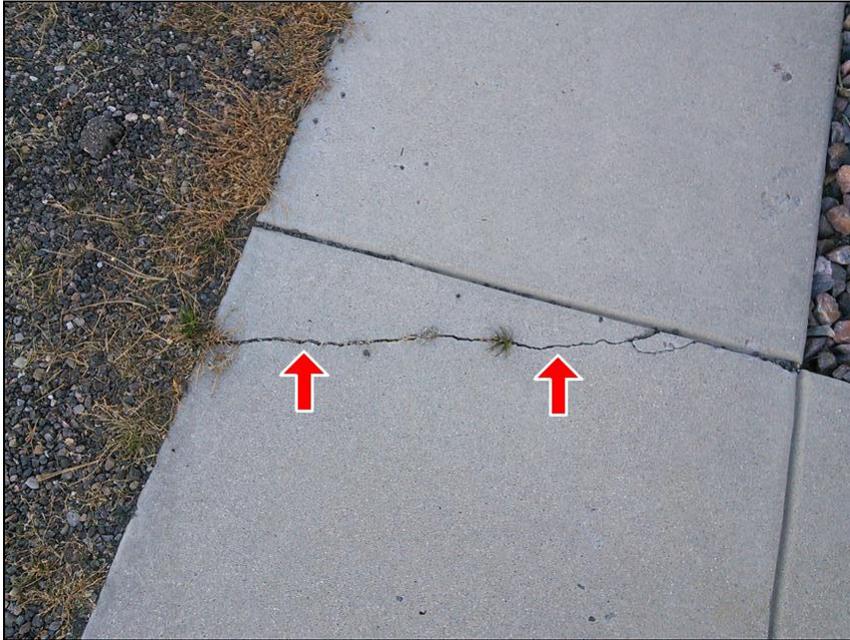
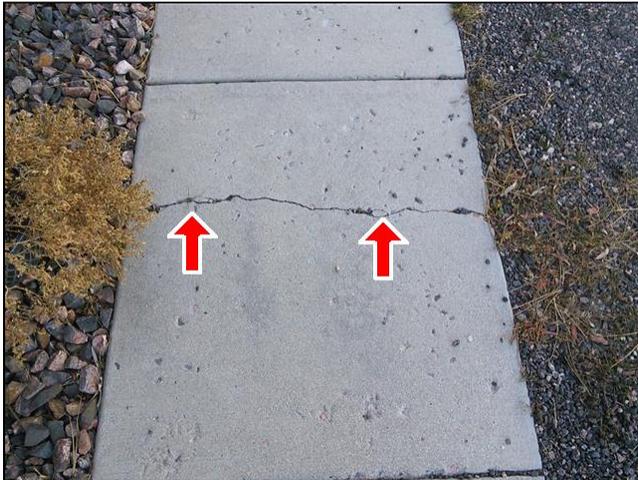
🏠 (4) Some settling of the walk way was noted. Settling of this nature (flat work) is typically not structural in nature. When these cracks are 1/4 inch or greater is is recommended to fill them with an appropriate sealant by a qualified technician.

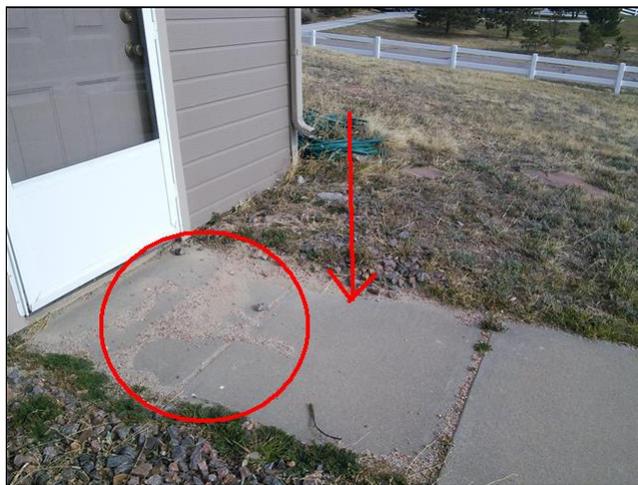
2.4 Item 11(Picture)

🏠 (5) By enlarge the drainage around the perimeter of the home appears to be adequate to move water away from the foundation. An area to observe over time is at the front of the home along side the garage. This area may have potential to hold moisture.

Also an area which may require more immediate attention is at the south side of the home by the back door in the south east corner. This area appears to allow moisture to collect and settle. The grading in this area can be improved to move water away. Also, there is a downspout with no extension at the same south east corner of the home. This should be extended to ensure water is not deposited in this area. (See section 1.3 #2 for further details)

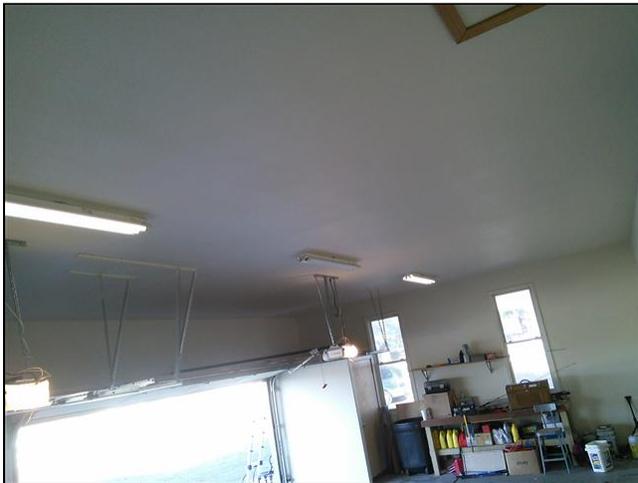
3.0 Item 1(Picture)

The garage ceiling appears to be in serviceable condition with no apparent breaches to the firewall.

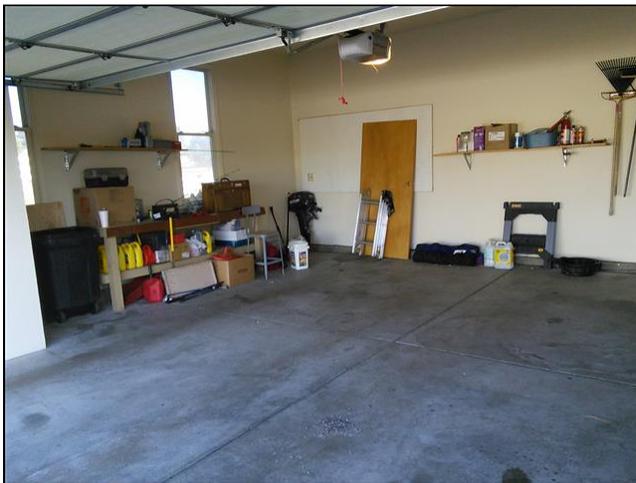
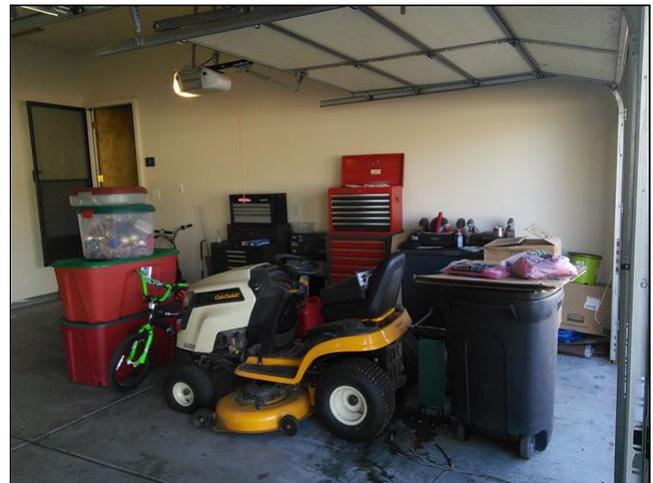
The walls appear to be in serviceable condition, some ceilings structures are obscured by building materials or items stored in the area making it impossible to perform a complete inspect of all surfaces. Do a careful check at final walk through.

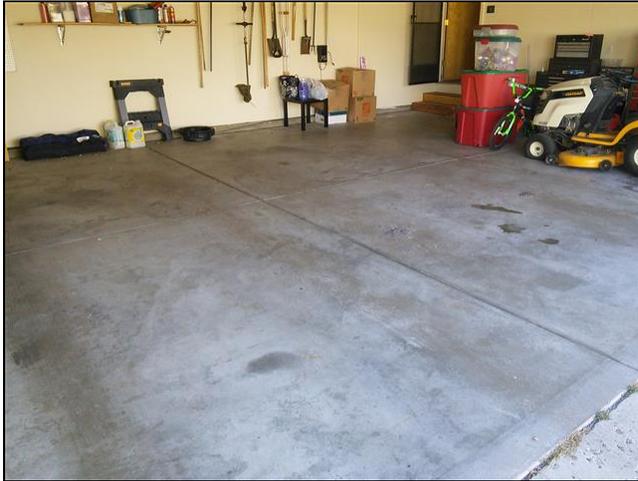
3.2 Item 1(Picture)

The garage floor that is visible appears to be in serviceable condition although some portions are obscured with materials stored in the garage making it impossible to perform a complete inspect of all surfaces. Do a careful check at final walk through.

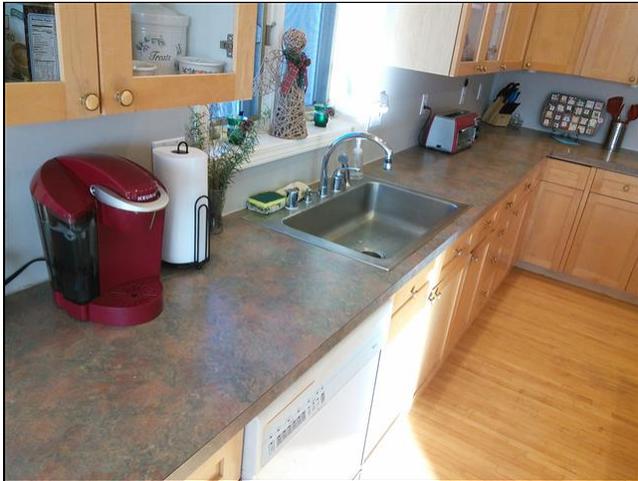
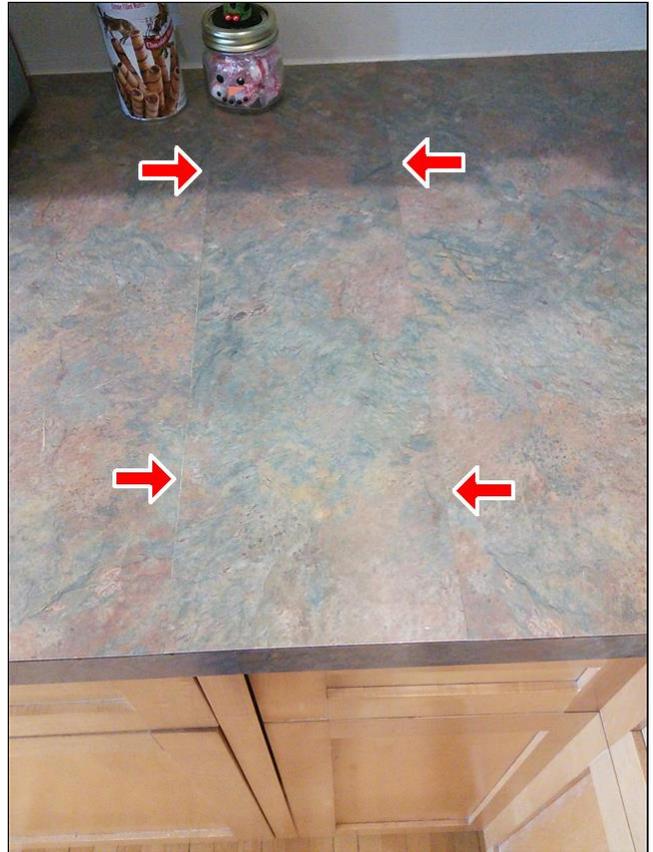
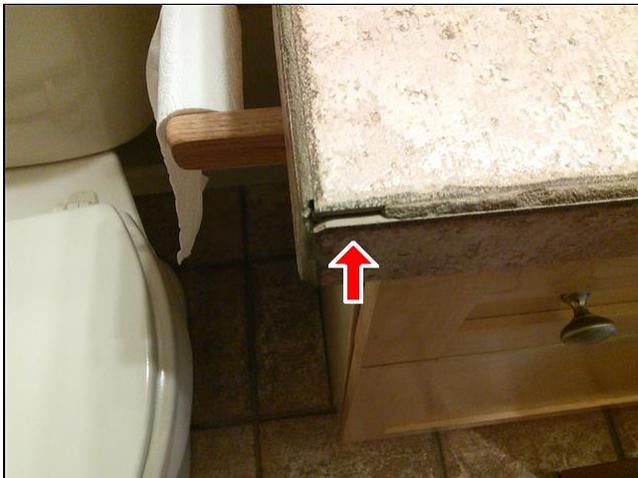
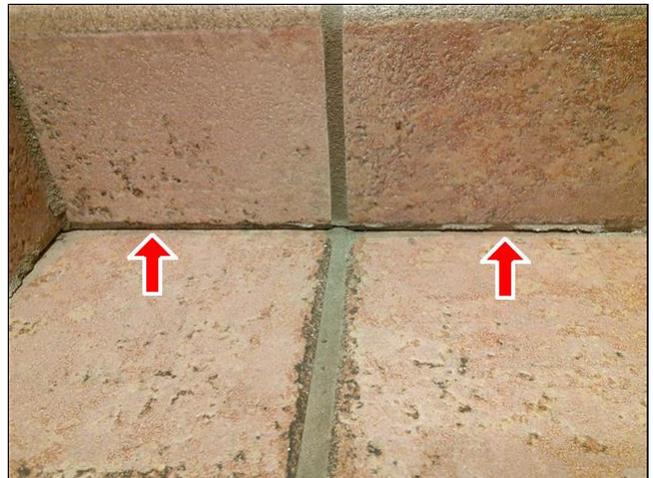
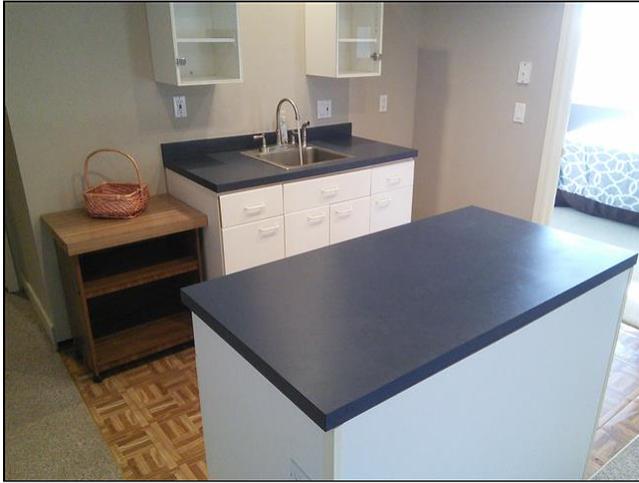
(1) The kitchen countertop appears to be in serviceable conditions. An apparent repair or non-standard installation was noted as indicated in image #2

The counter in the hall bath is missing grout in some areas and would benefit from caulking maintenance as illustrated in images #3 and #4

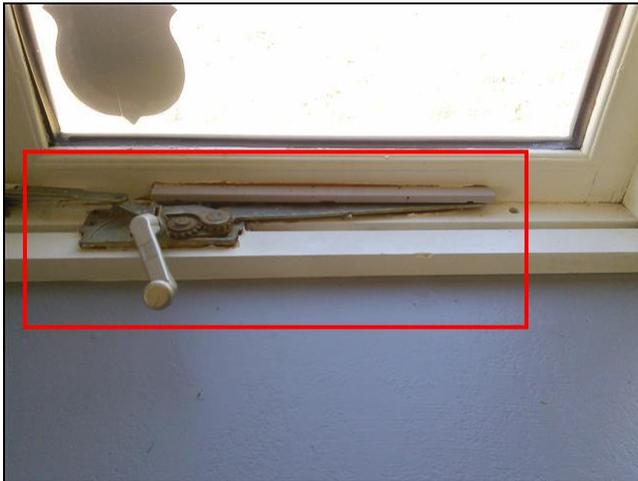
4.6 Item 1(Picture)

📍 (3) The window in the basement office on the west wall is missing the crank mechanism enclosure, as well the crank on the right window was not operable at time of inspection. These windows were also missing screens.

It is recommended to inquire of a window professional as to the cost of these repairs prior to closing.

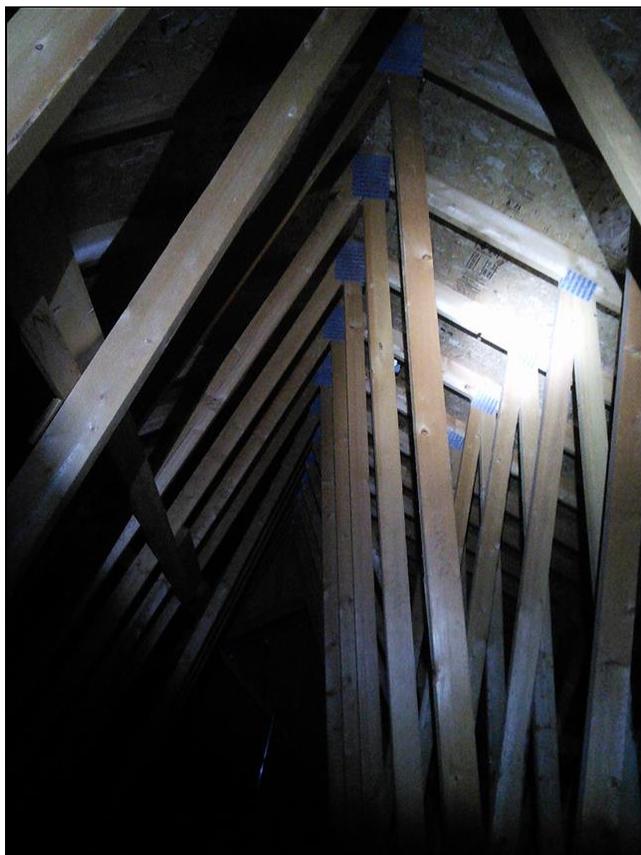
5.5 Item 1(Picture)

The attic structure showed no signs of water penetration at time of inspection and appears to be serviceable, however, the inspector is unable to see the entire rafter framing due to the insulation and/or accessibility.

The attic cavity is not useable for any storage due to size, framing, or insulation.

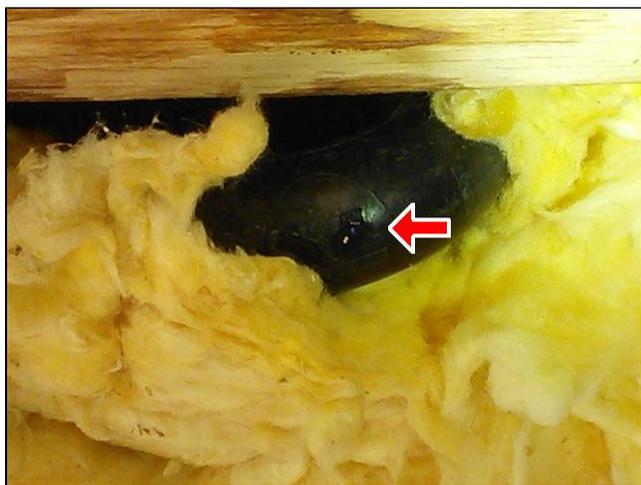
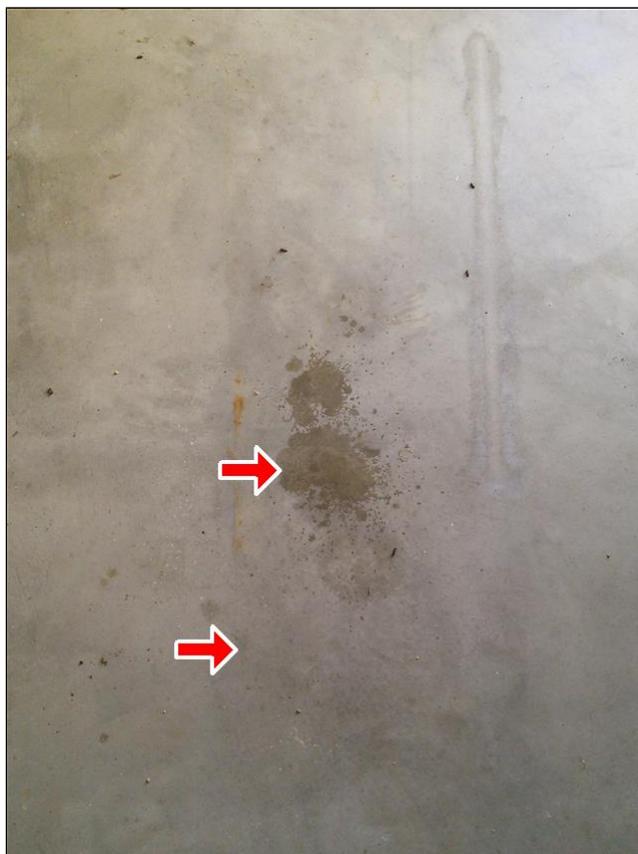
🏠 (2) The drain for the jacuzzi tub at the master bathroom appeared to be leaking at the time of inspection. Note the moisture on the P-trap in image #1 as viewed from unfinished portion of the basement, also signs of previous water on the concrete floor, as well as active moisture. It is recommended to have this condition repaired by a qualified licensed plumber.

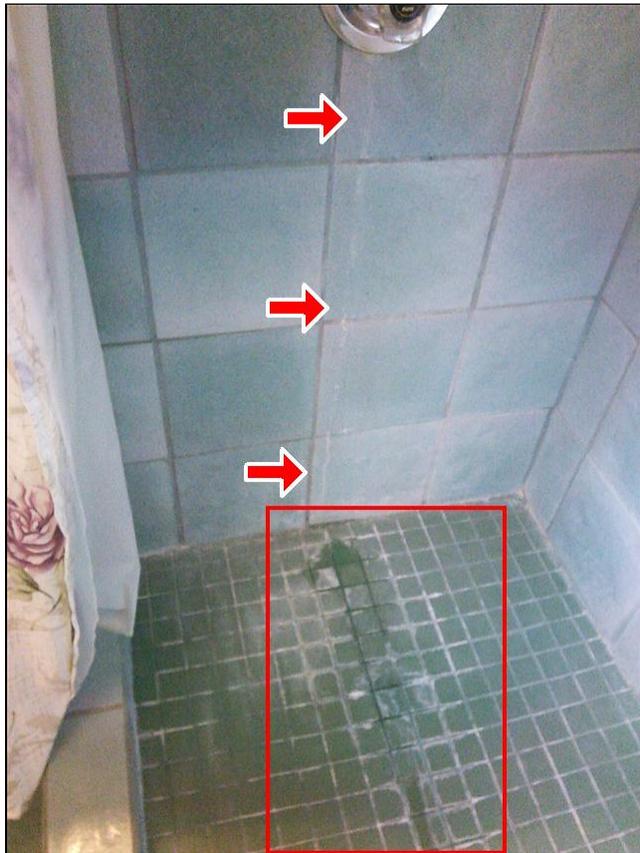
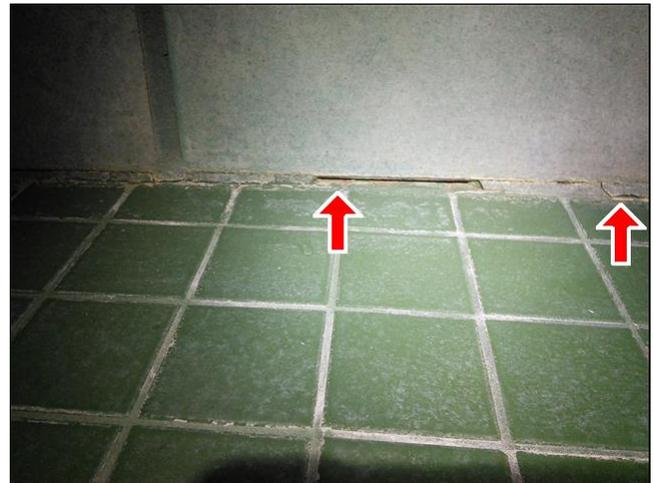
🏠 (1) The water supply valve at the basement bathroom shower appears to be leaking as is indicated by the calcium buildup in the shower pan and continuously present moisture.

Also, caulk or grout repair is indicated at the basement shower to reduce possibility of water infiltration outside of the shower pan.

It is recommended to consult with a licensed plumber for repair

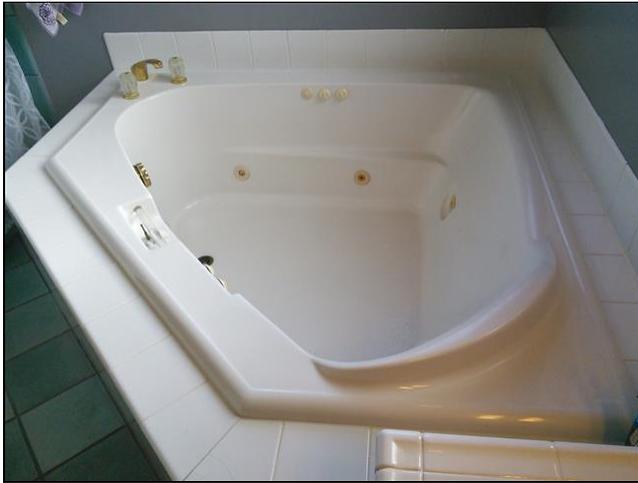
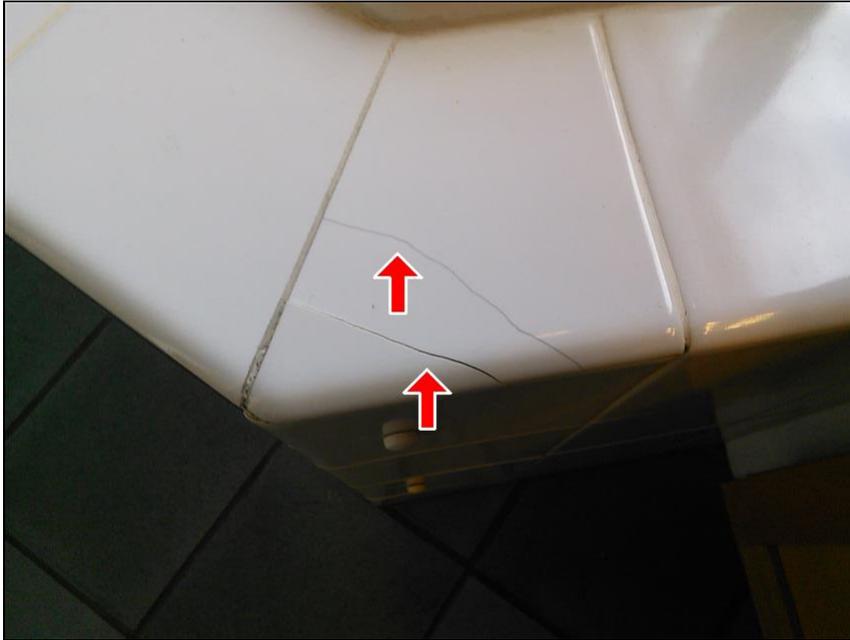
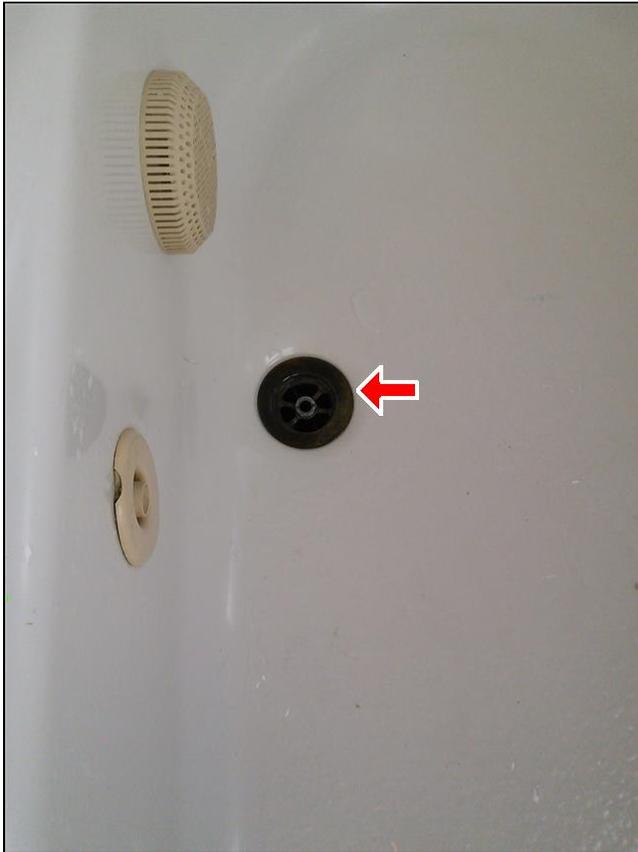
🏠 (2) It was not possible to test the jacuzzi tub at the master bathroom. This was due to the tub drain which appeared to be leaking as noted in section 6.0 #2.

Jacuzzi tubs typically have access to the pump and motor normally stored within the enclosure. It appeared as if this access was there, but due to broken tiles at it's perimeter, the inspector did not feel that this access panel could be removed without risk of further damaging these tiles.

It was also noted that the tub drain stopper was not operational at the time of inspection.

It is recommended that this condition be repaired by a licensed plumber and the jacuzzi tub operation be validated.

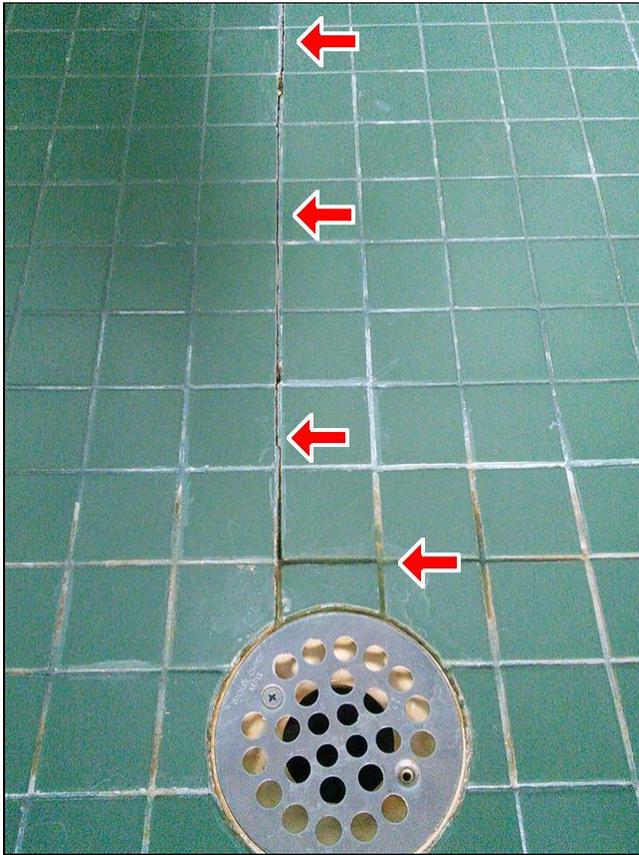
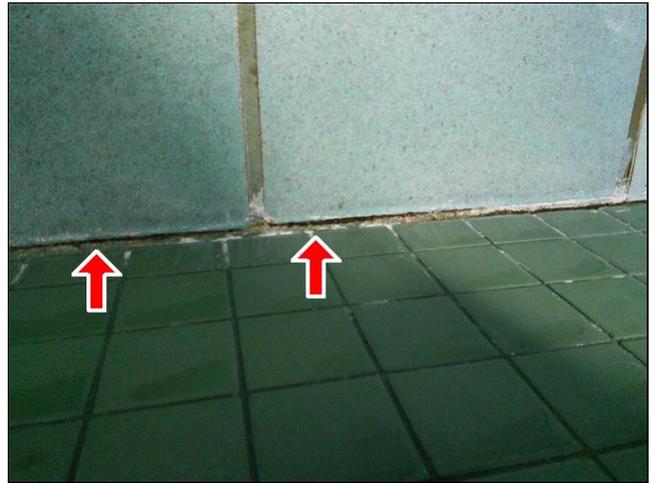
📍 (3) Missing tile grout was noted at the shower stall in the master bathroom.

It is recommend to repair or preplace as needed to avoid water damage.

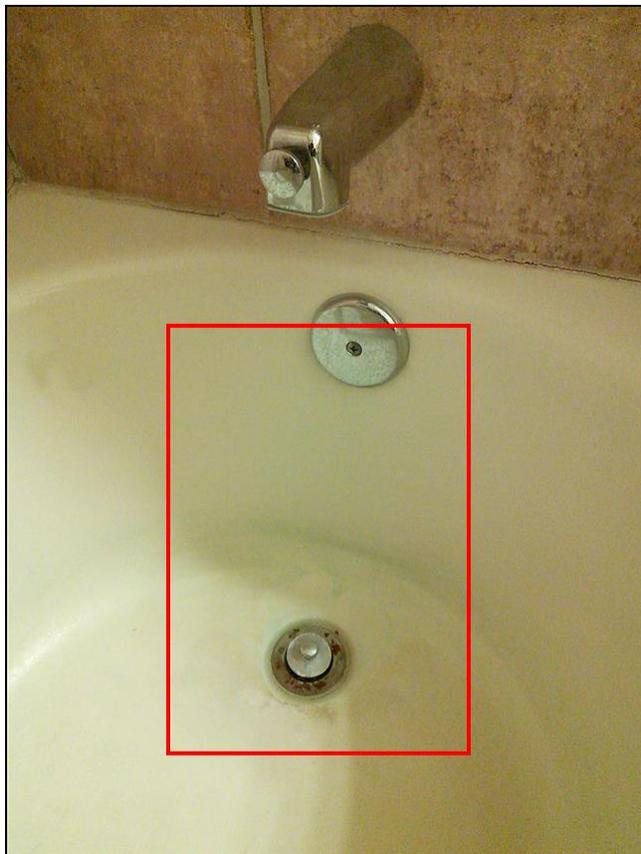
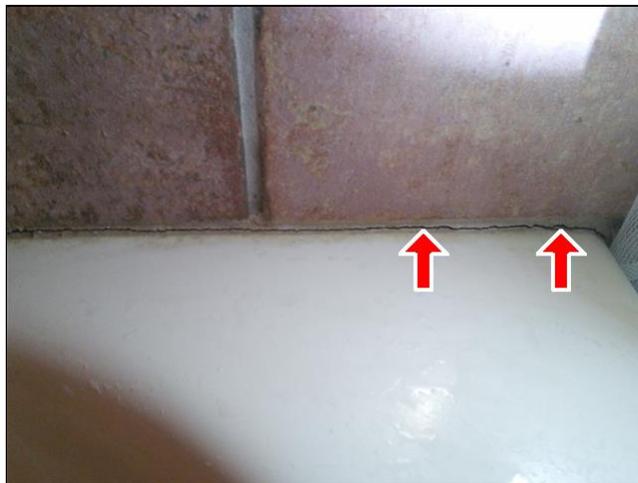
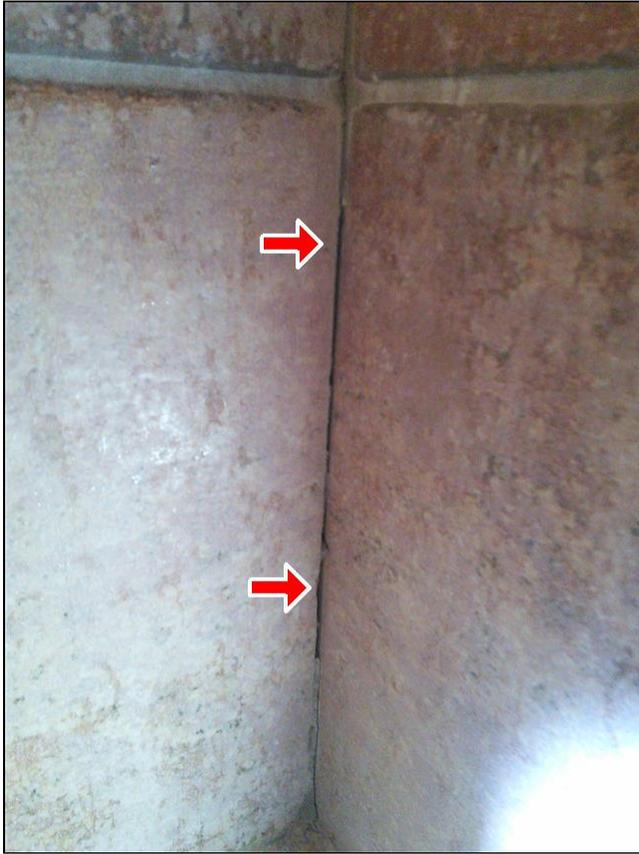
🏠 (4) Signs of an active leak was noted at the hallway bathroom tub/shower. An active drip was observed and build up of minerals on the tub surface. In addition the tile enclosure had areas of grout and caulk that were in need of repair.

It is recommended that a qualified technician repair this leak and repair grout/caulk to prevent damage as needed.

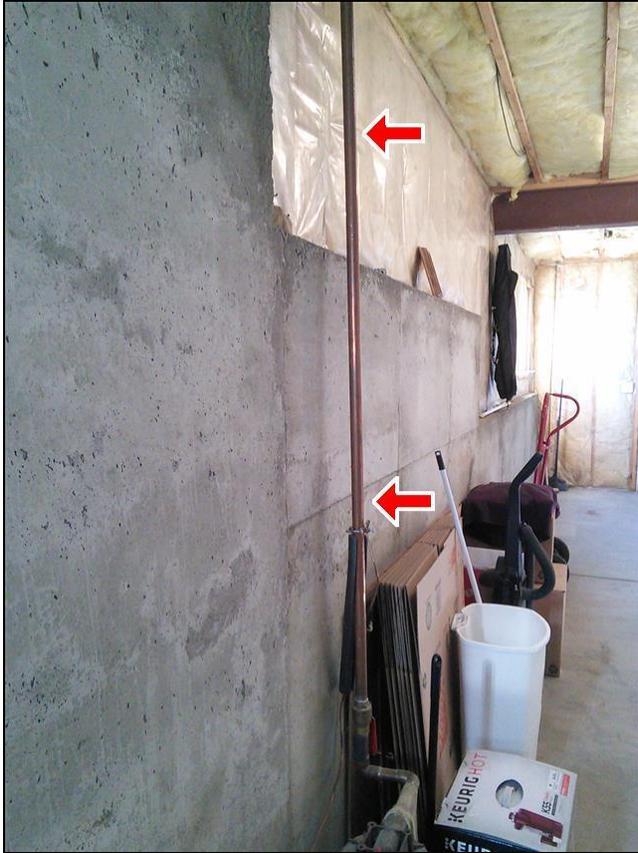
6.1 Item 13(Picture)

(7) Vertical copper piping is typically supported every 10 feet minimally. The vertical line in the unfinished portion of the basement as it enter the home would benefit from an additional support.

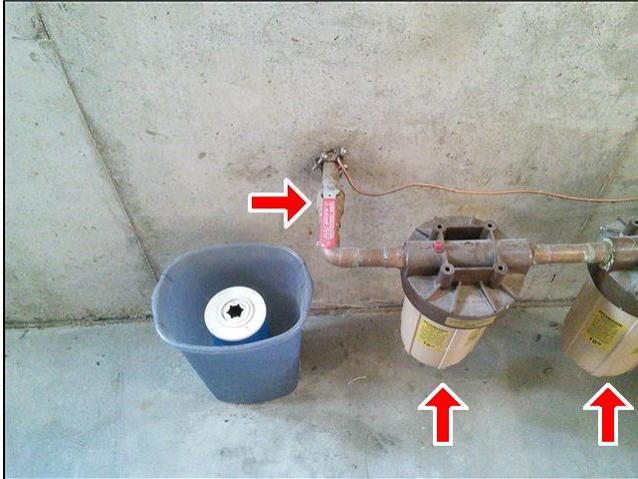
6.3 Item 1(Picture)

The main water shut-off is located in the crawl space on the north wall. Noting the location of the main incoming water valve is important in the event of a plumbing emergency requiring rapid shut down of water flow into the home.

Also note that the main incoming water line has an inline sediment filter installed. The adjacent image shows the filter canisters. Most sources recommend replacing the filter ever 3 to 6 months. This is important particularly considering the home is heated by a hydronic system and keeping the boiler and distribution lines clean is important. (see recommendation on section 8.3 #2)

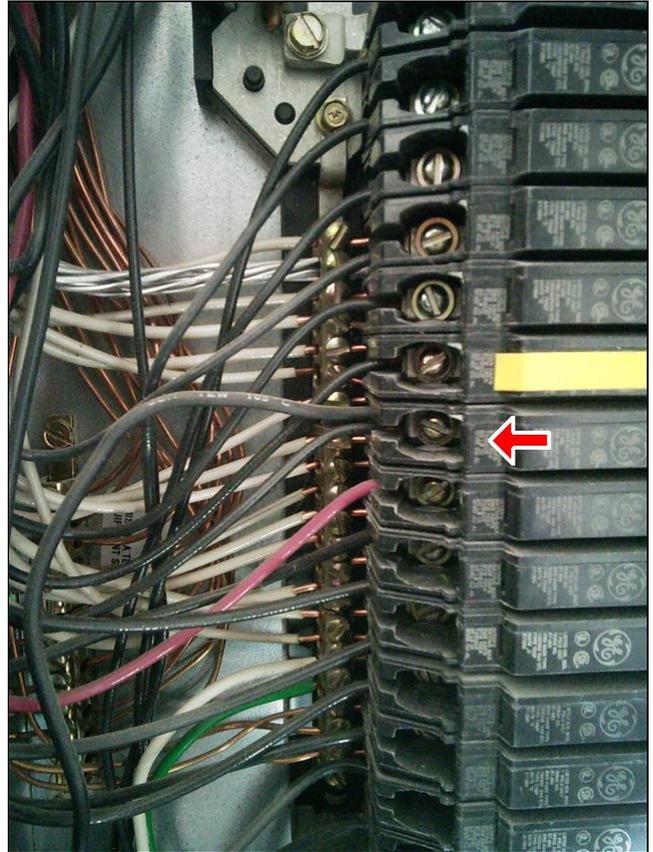
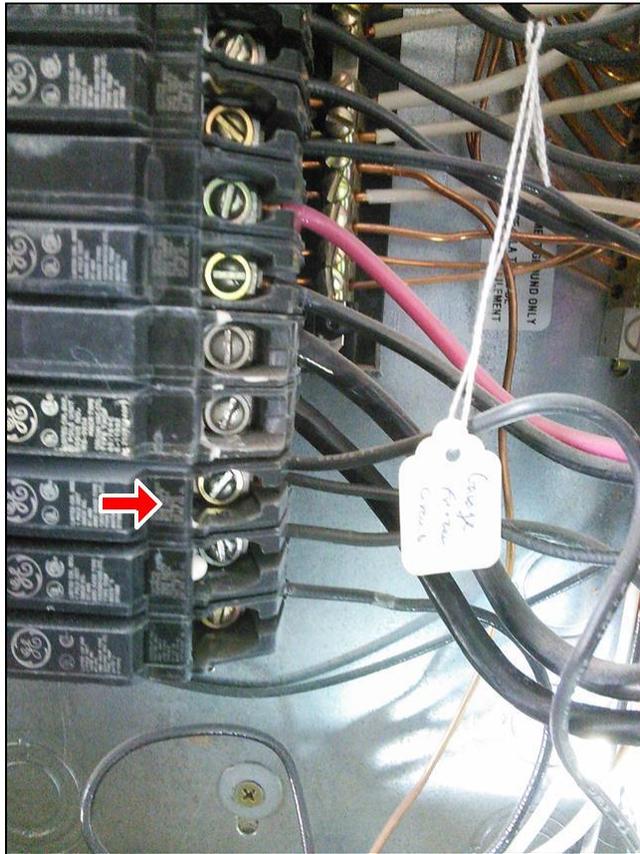
In the panel, two wires were connected to a single breaker designed for only one wire. This is known as a "double-tapping" or "double-lugging" and is a condition that should be corrected by a qualified electrical contractor.

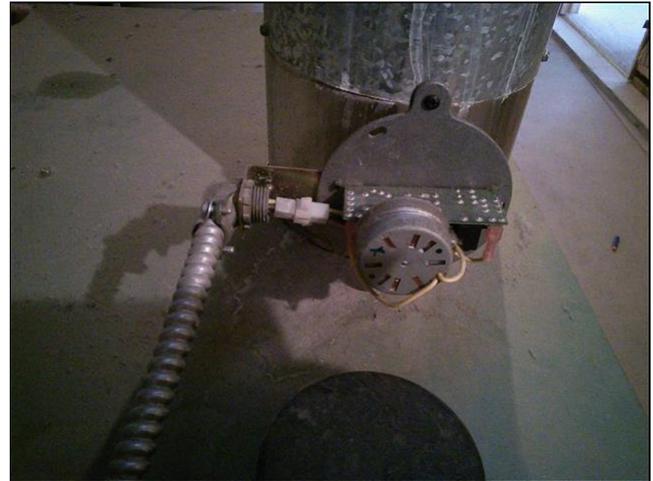
7.3 Item 2(Picture)

(4) Some exposed electrical connections were noted at the boiler in the unfinished portion of the basement. As this could cause electrical shock injury, it is recommended that the proper enclosure cover be installed at these locations by a licensed system repair professional.

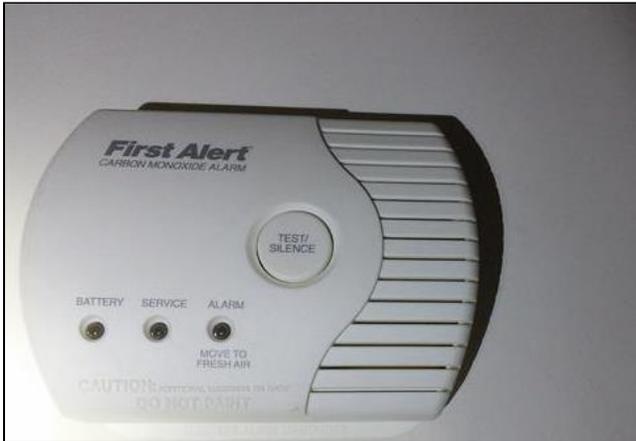
7.8 Item 1(Picture)

As of July 1st, 2009, carbon monoxide detectors are required in Colorado within 15 feet of the entrance to any bedroom. We noted that the detector in the main level hallway was not operational at the time of inspection. To be in full compliance, this carbon monoxide detector needs to be installed or repaired.
