Residential Property Inspection Services

Inspection Report

Property Address:
1000 Rock River Rd
Denver CO 80000

Cozy Home Inspection Services LLC

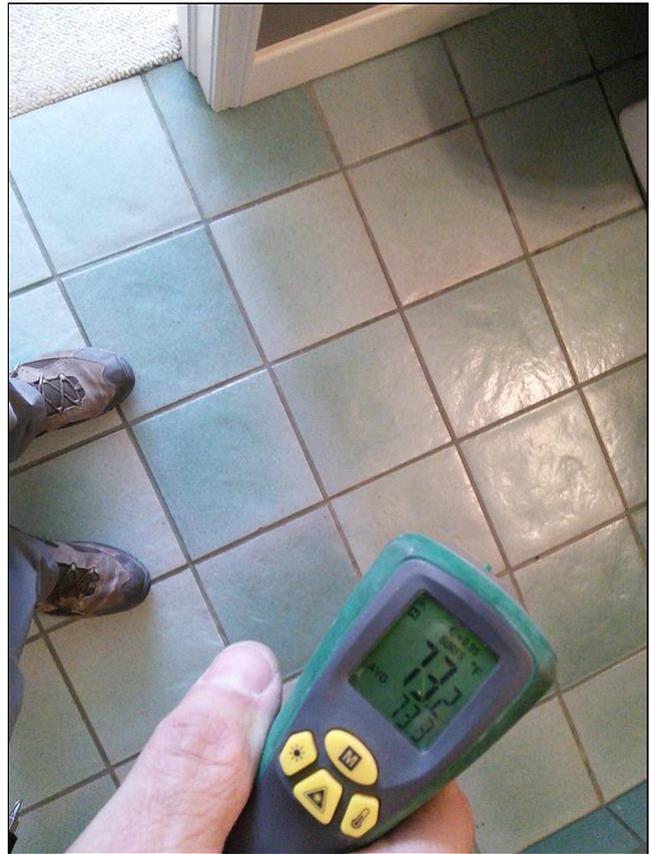
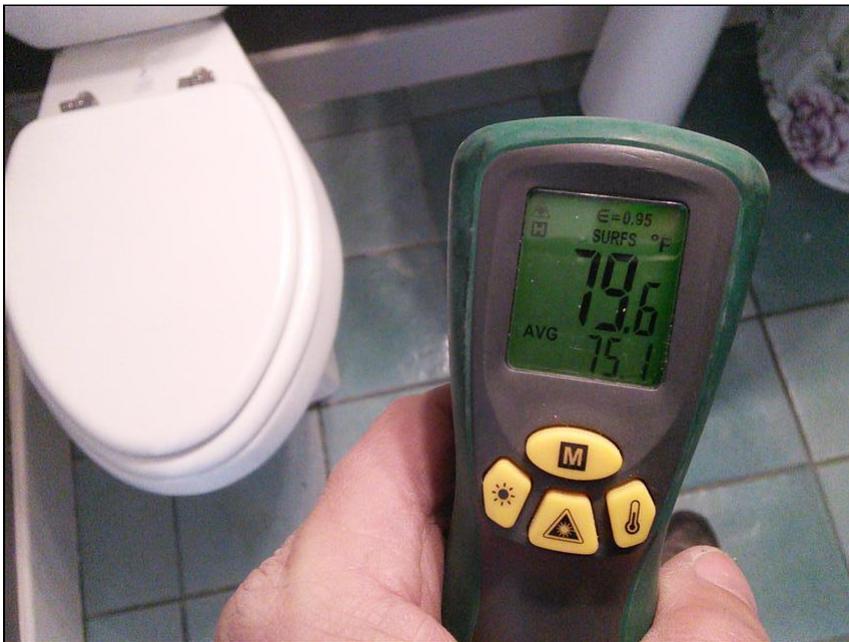
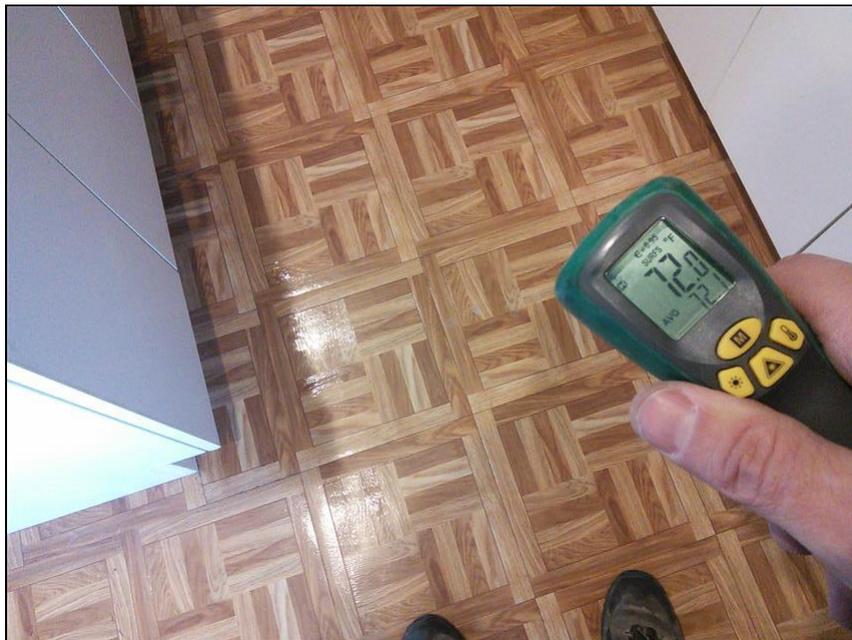
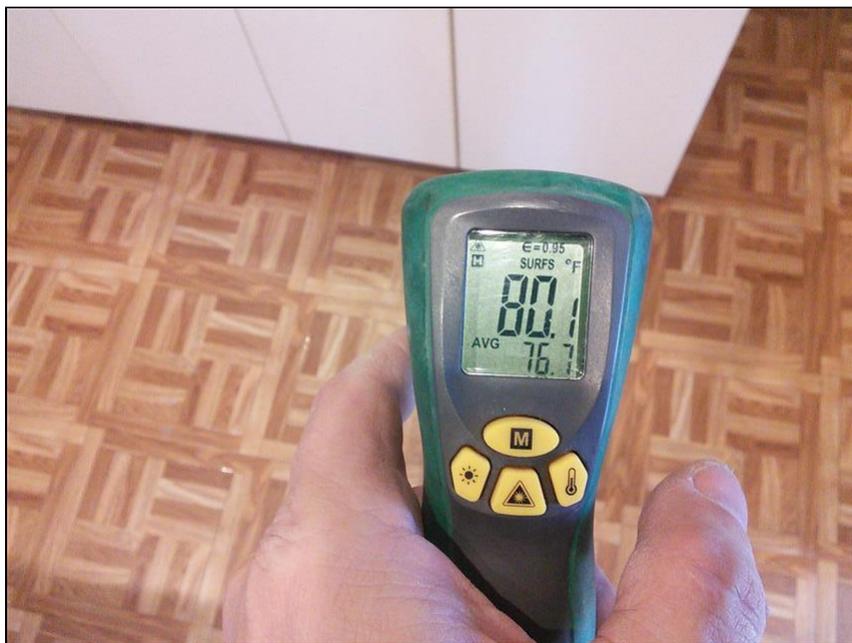
Additionally, some areas of the home, particularly the basement, appear to be heated by radiant floor heating, fluid heated by the boiler and circulated through pipes installed in the floor structure. This is surmised by noting the water heater manifold located in the unfinished portion of the basement (see image #10) and the floor temperature differential particularly noted in the basement wet bar area and the basement bathroom (see images #6-8)

Hydro-thermal heating systems are an uncommon heating source and is typically beyond the scope of a standard home inspection. As this is a specialized system, and that a potential issue was noted with the kitchen baseboard heater, it is recommended that this system (boiler, venting, and distribution) undergo a full inspection by a qualified HVAC contractor that specializes in hydro-thermal heating systems prior to closing on the property. (see sections 7.3 #4, section 8.3 #1 & #2, section 8.4 #2)

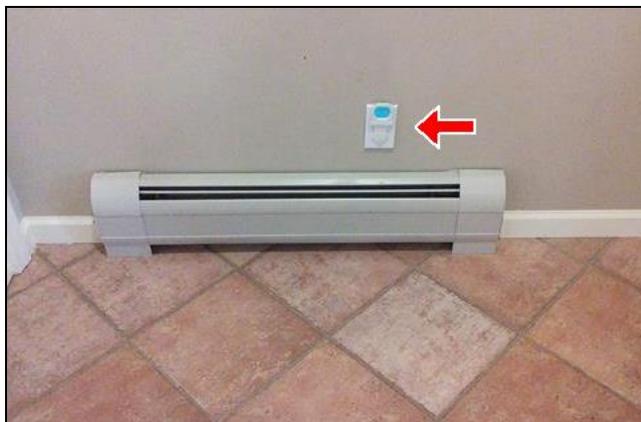
8.0 Item 11(Picture)

🏠 (2) Electrical outlets above baseboard heaters is typically not a good practice as electrical cords plugged into these outlets could be damaged by the heat of the baseboard heater. this condition was noted at the front door. It is recommended that this receptacle be removed, the wires capped off and a blank cover be installed at this location by a licensed electrician.

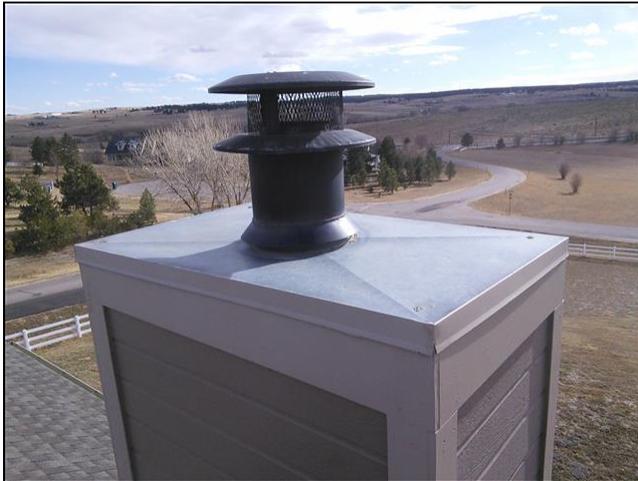
8.4 Item 1(Picture)

(1) The furnace and fireplace flue is not fully visible, due the limited access, and cracks or disconnections may occur causing a fire hazard. Therefore, it is always advisable to have a complete evaluation by and specialist and, if necessary, repairs by a certified qualified technician.

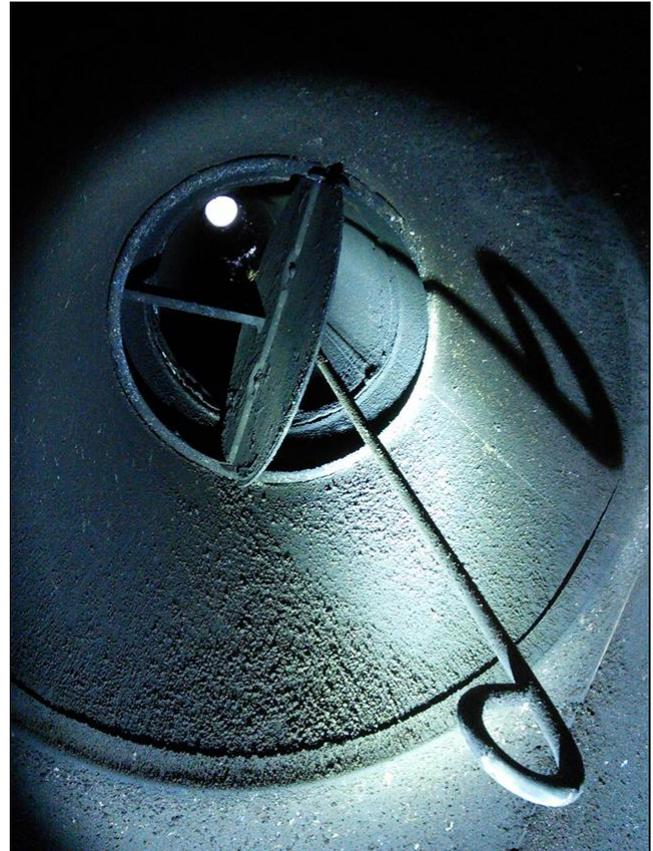
8.4 Item 2(Picture)

🏠 (2) The boiler exhaust flue termination may not extend far enough above the roof. This condition could cause inadequate drafting which could allow the toxic products of combustion to enter the living space due to backdrafting. Exhaust flue termination heights are specified by the manufacturer and local jurisdictions. The Inspector recommends contacting the boiler manufacturer or a HVAC specialist to confirm proper exhaust flue termination height and clearances. Additionally, a carbon monoxide detector installed near the boilers location is recommended.

Note: A common standard for the top of the vent cap on the roof is that it should be at least two feet above anything within a ten-foot radius of the chimney.

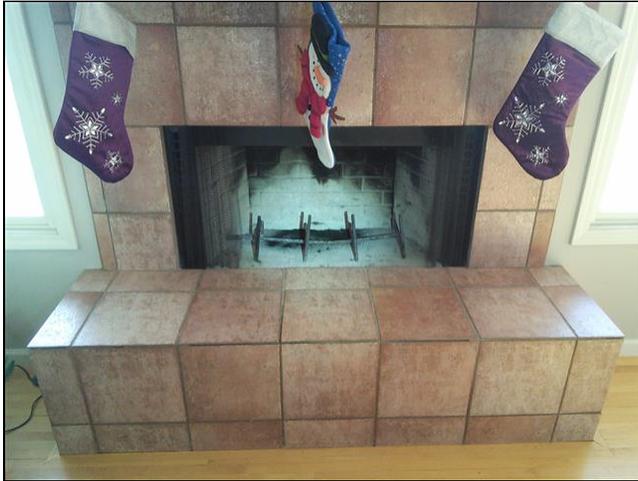
8.5 Item 1(Picture)

(2) The hearth at the wood burning fireplace had missing areas of grout. It is recommended to repair as desired.

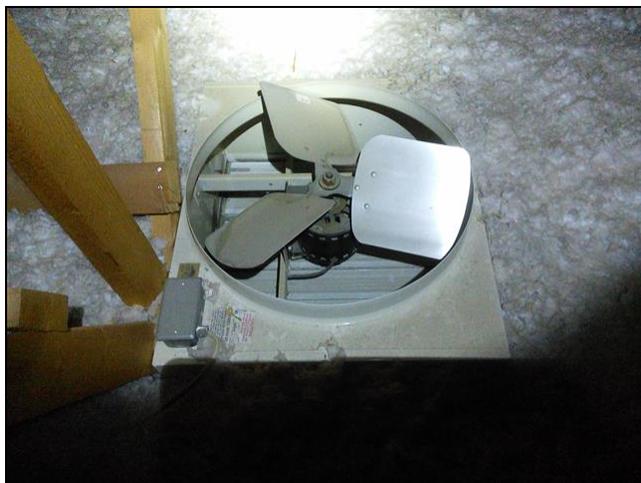
8.6 Item 1(Picture)

air to the home exterior through attic ventilation devices such as roof, soffit, gable or ridge vents. While whole-house fans can be effective at removing heat from a home at a relatively low cost compared to other types of cooling equipment, but they can be somewhat noisy. During the heating season, the opening in the ceiling can be sealed with an insulated cover to reduce heat loss, this type of cover was not present at the time of inspection.

IMPORTANT: While the whole-house fan is in use, it is important that windows be partially opened to avoid depressurizing the home, a condition which can pull toxic exhaust gases from combustion appliances into indoor air.

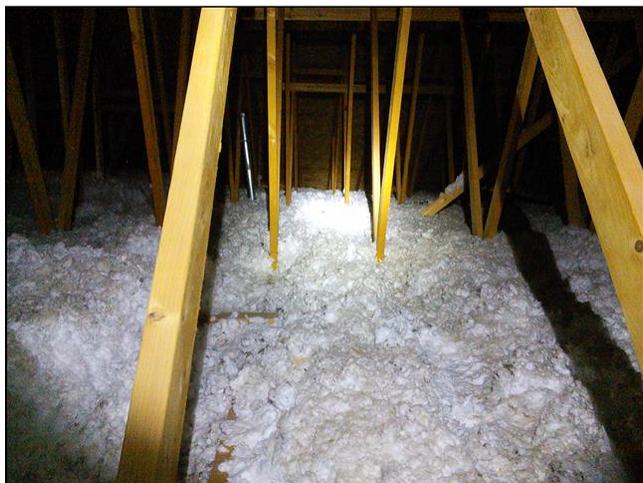
9.0 Item 1(Picture)

The attic insulation appears to be adequate and properly installed. It appears to have an R-value of approximately R-19 While R-38 may be recommended, the current insulation is consistent with the age of the home and standards at time of construction.

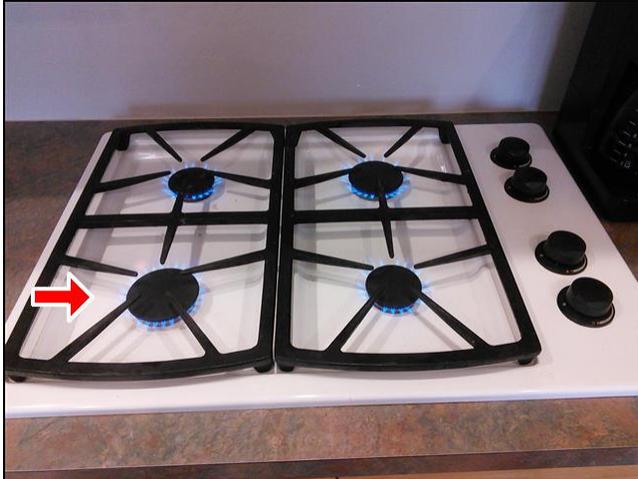
10.1 Item 1(Picture)

🏠 (1) The range burners were in need of cleaning or adjustment, particularly the front left burner. Lighting each individual burner operated as expected but turning the burner to the lowest setting resulted in the flame

blowing out on that particular burner. It is recommended to clean and/or adjust the gas flow as needed for safe operation by a qualified technician.

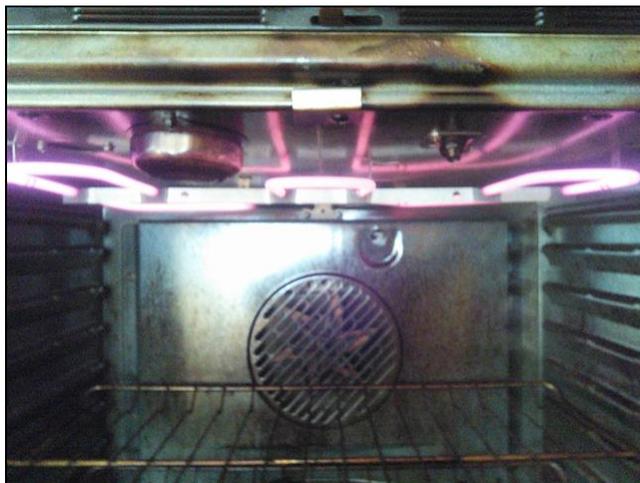
10.1 Item 5(Picture) Upper oven broiler element

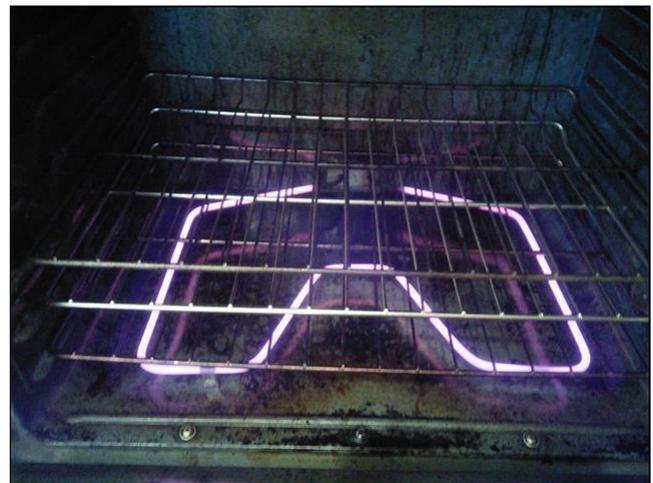
10.1 Item 6(Picture) Upper oven bake element

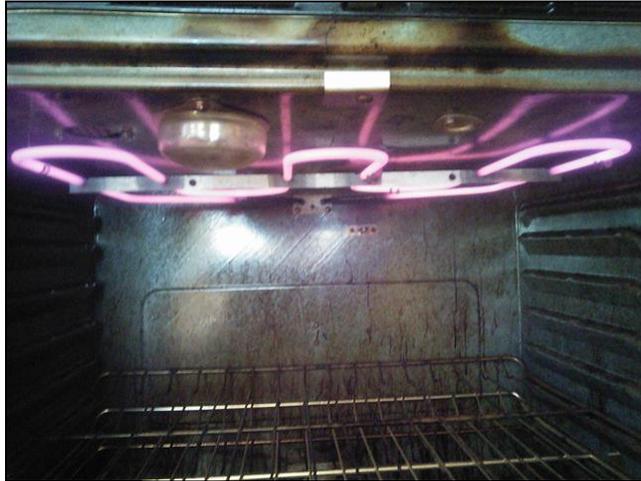
10.1 Item 7(Picture) Lower oven broiler element

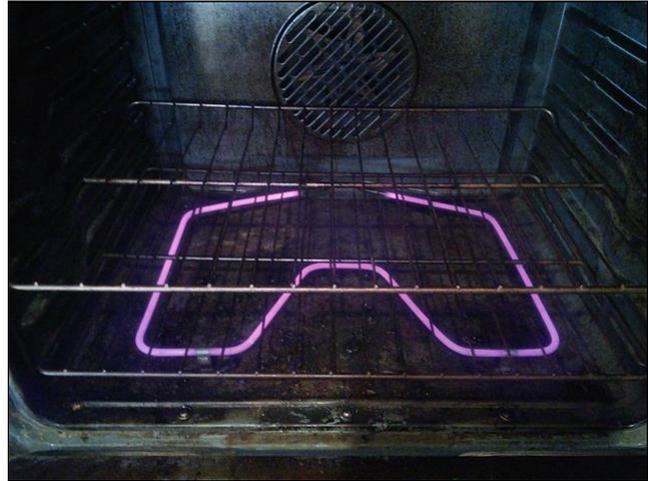
10.1 Item 8(Picture) Lower oven bake element

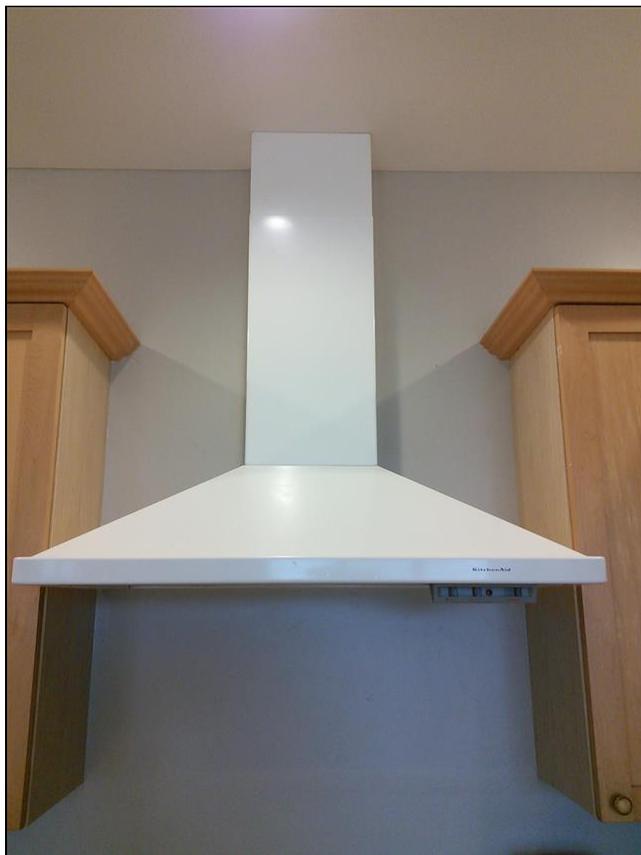
10.2 Item 1(Picture)

The externally vented range hood was in serviceable condition at the time of inspection.

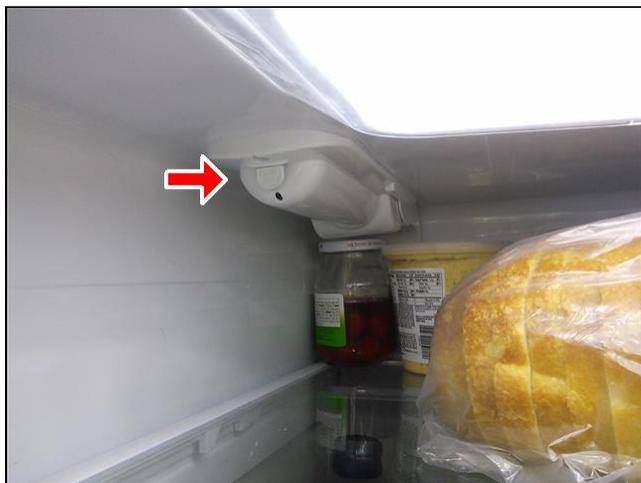
10.5 Item 5(Picture)

(2) The refrigerator has a water filter installed. (Testing of water filtration is not part of standard home inspection).

It is recommend to replace this filter after closing on the property.
